# Beneficial Use of Dredged Material to Enhance Salt Marsh Habitat in New Jersey

## Project Summary and Lessons Learned August 2021

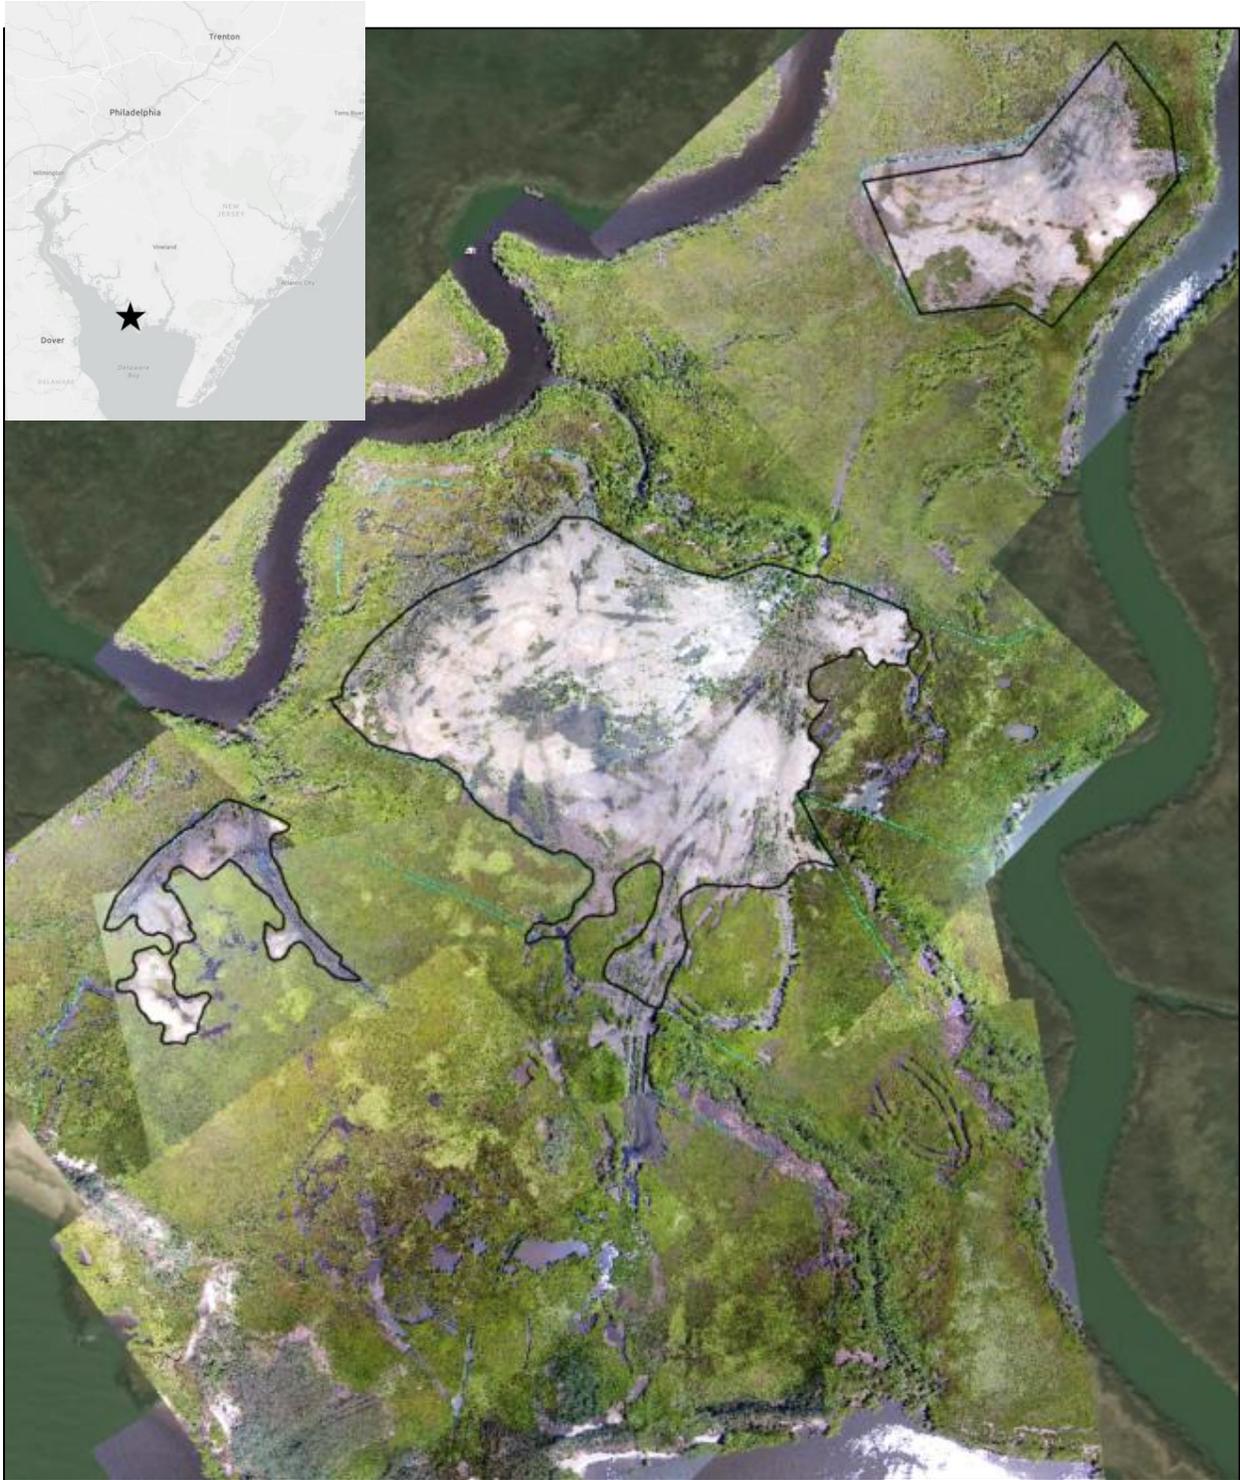
*This drone photo shows the salt marsh enhancement project in Fortescue, NJ, after sediment was added (outlined in black). Photo credit: TNC 2016*

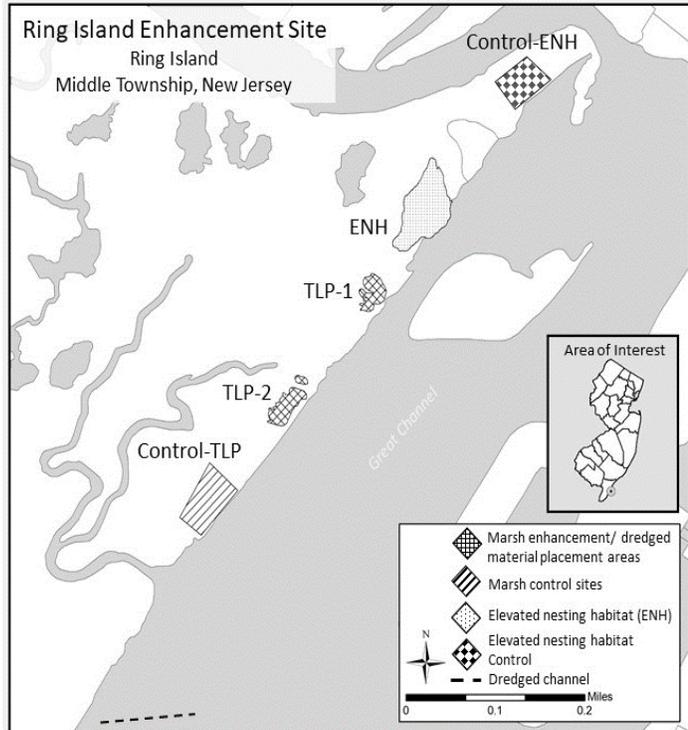
**Figure 2.** This map of the Ring Island site shows the elevated nesting habitat (ENH), the marsh enhancement thin-layer placement areas (TLP-1 and TLP-2), and the control areas (Control-ENH and Control-TLP).

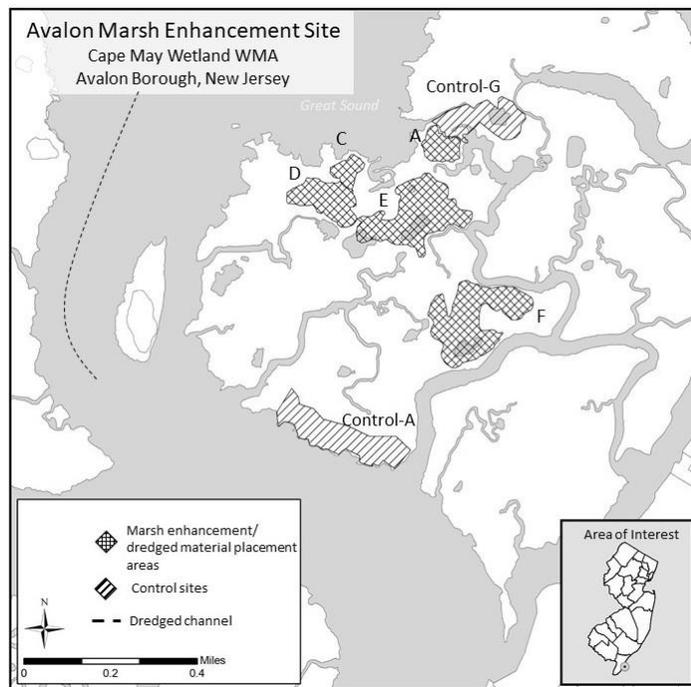
**Figure 3.** This map of the Avalon site shows the locations of the marsh enhancement areas (A through F) and marsh control areas (Control-A and Control-G).

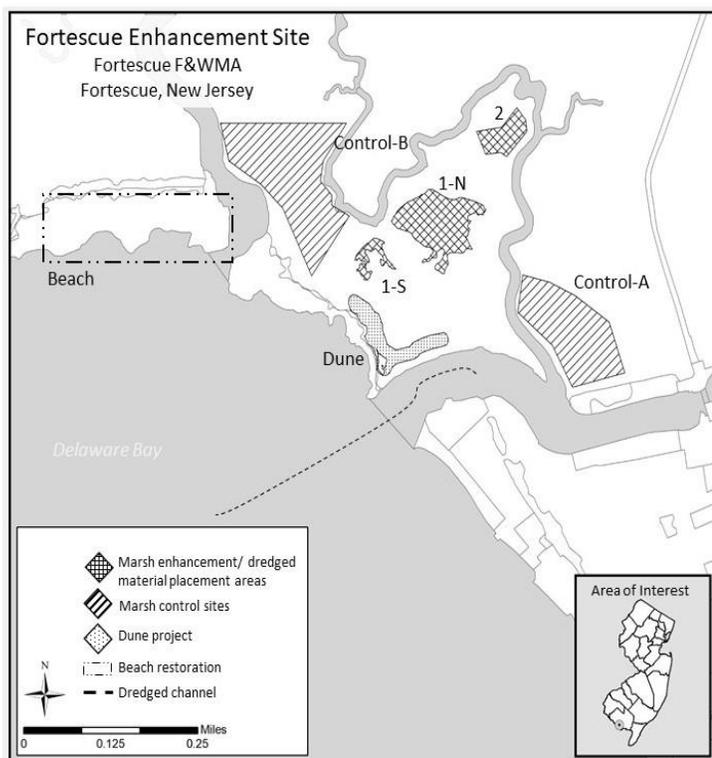
**Figure 4.** This map of the Fortescue site shows the locations of the marsh enhancement (1-S, 1-N, and 2), dune restoration (Dune) and beach nourishment (Beach) dredged material placement areas and the marsh control sites (Control-A and Control-B).

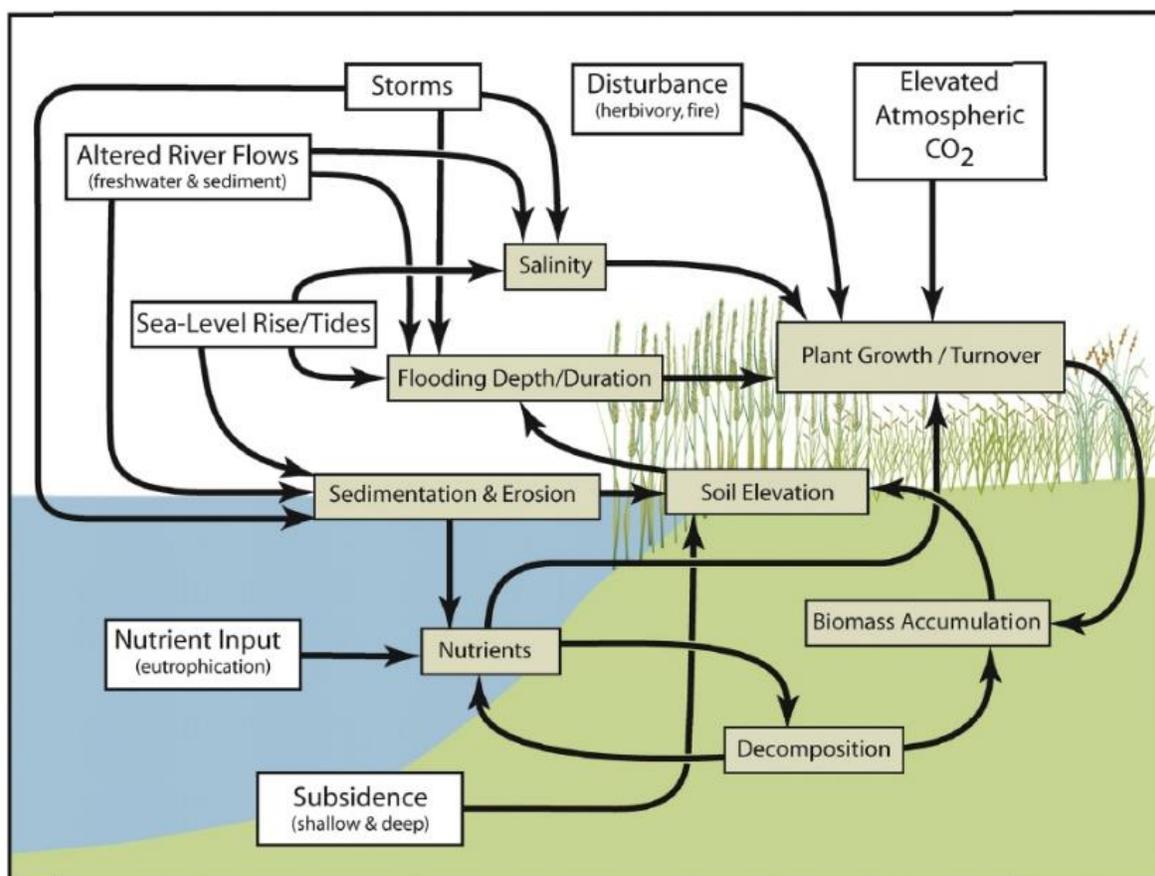
**Figure 6.** This conceptual model of a tidal marsh shows how substantial tidal inputs of mineral sediment are influenced by environmental drivers and factors affecting accretion processes (Cahoon et al. 2009).

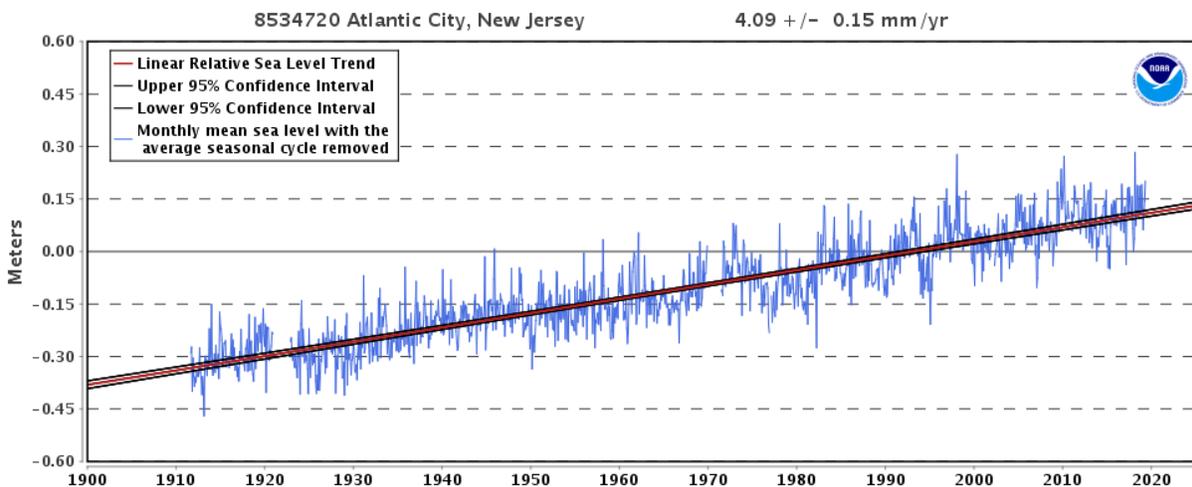
**Figure 7.** The relative sea-level trend is an increase of 4.09 mm/year, with a 95% confidence interval of +/- 0.15 mm/year, based on monthly mean sea-level data from 1911 to 2018. This is equivalent to a change of 1.34 feet in 100 years (NOAA. [https://tidesandcurrents.noaa.gov/sltrends/sltrends\\_station.shtml?id=8534720](https://tidesandcurrents.noaa.gov/sltrends/sltrends_station.shtml?id=8534720). July 1, 2019).

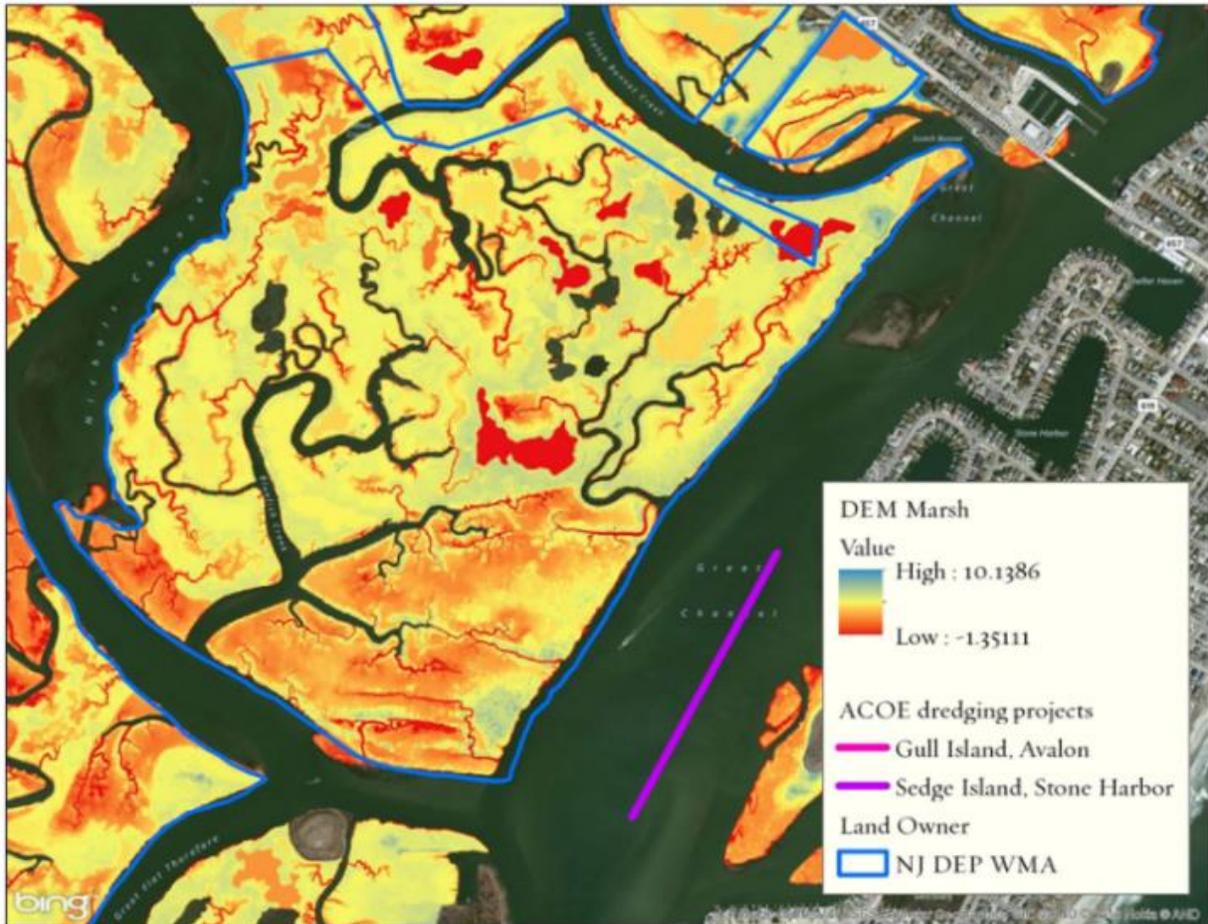
**Figure 8.** This LiDAR map of Ring Island shows the relative elevation of salt marsh sites. Areas in red were especially low elevation and were selected for further evaluation.

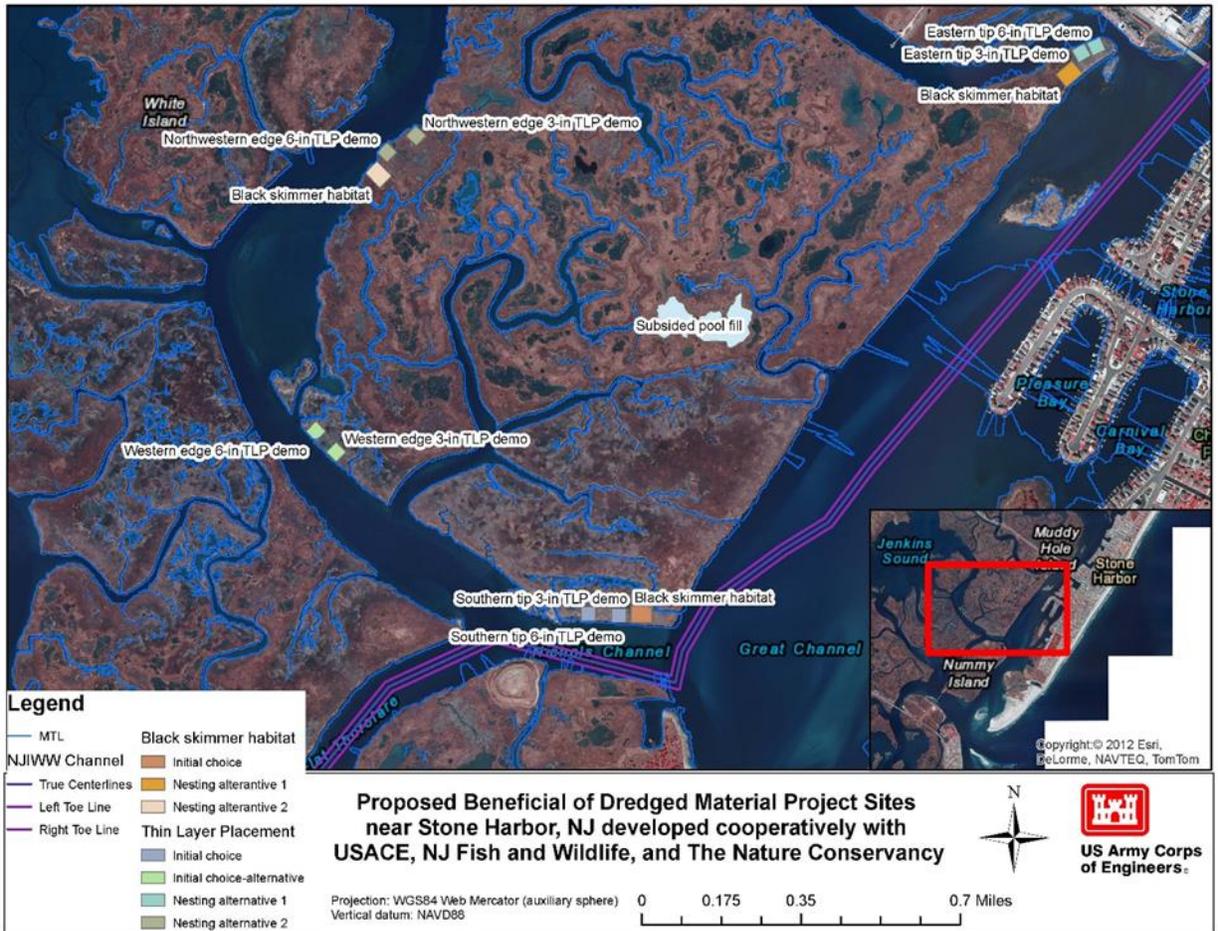
**Figure 9.** This map shows the initial potential sites on Ring Island, with priority and secondary choices for the creation of black skimmer habitat and marsh enhancement. None of these areas were used because birds were nesting there during the scheduled construction time.

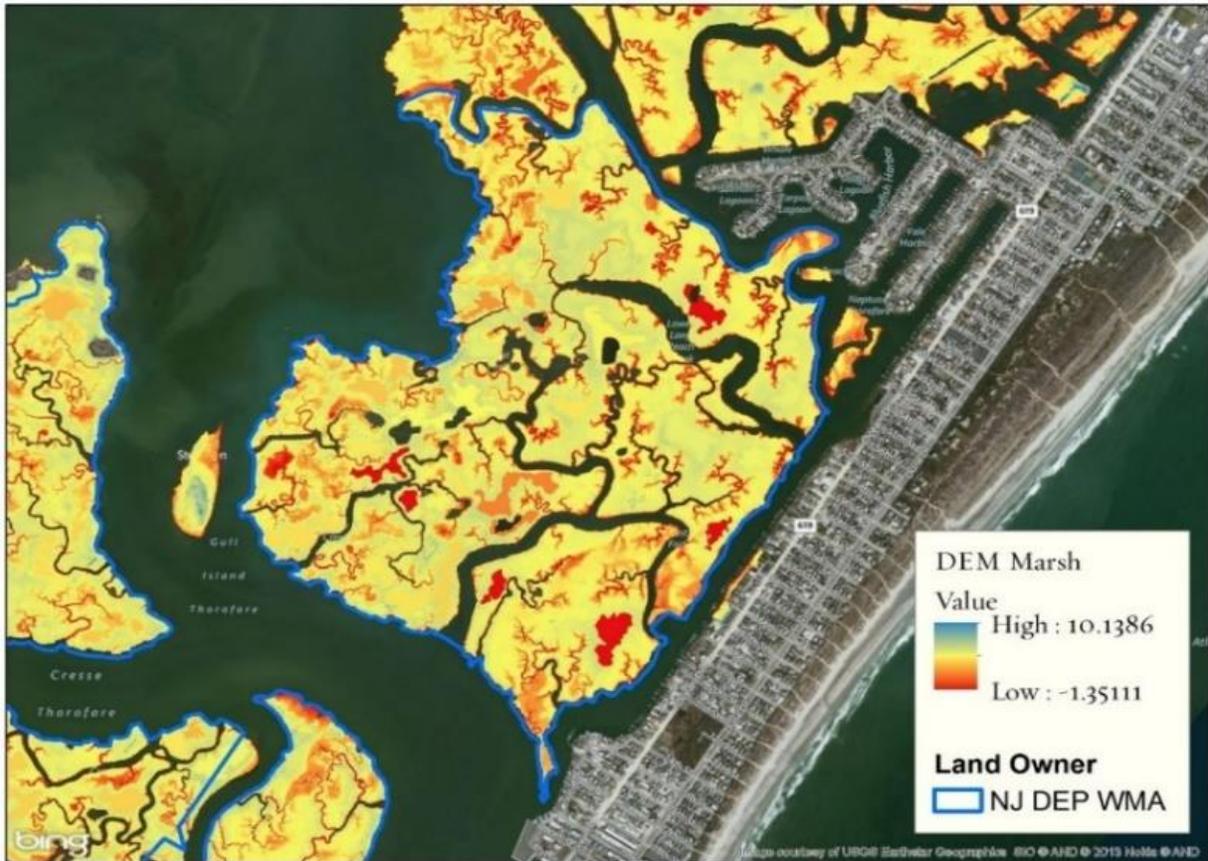
**Figure 10.** This LiDAR map of the marsh at Avalon shows the relative elevations of state-owned marsh near planned dredging and was used in combination with other information to preliminarily select marsh enhancement areas.

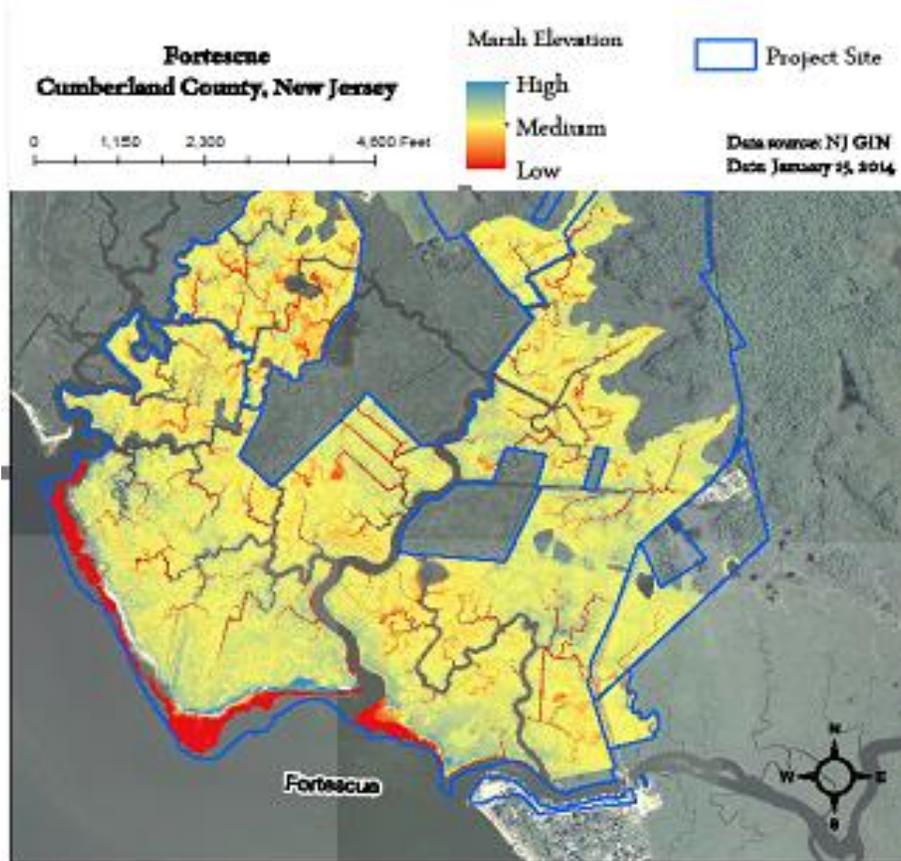
*Figure 11. This LiDAR map of the Fortescue site shows the relative elevations of state-owned marsh near the planned dredging area. This map was used in combination with other information to preliminarily select marsh enhancement areas.*

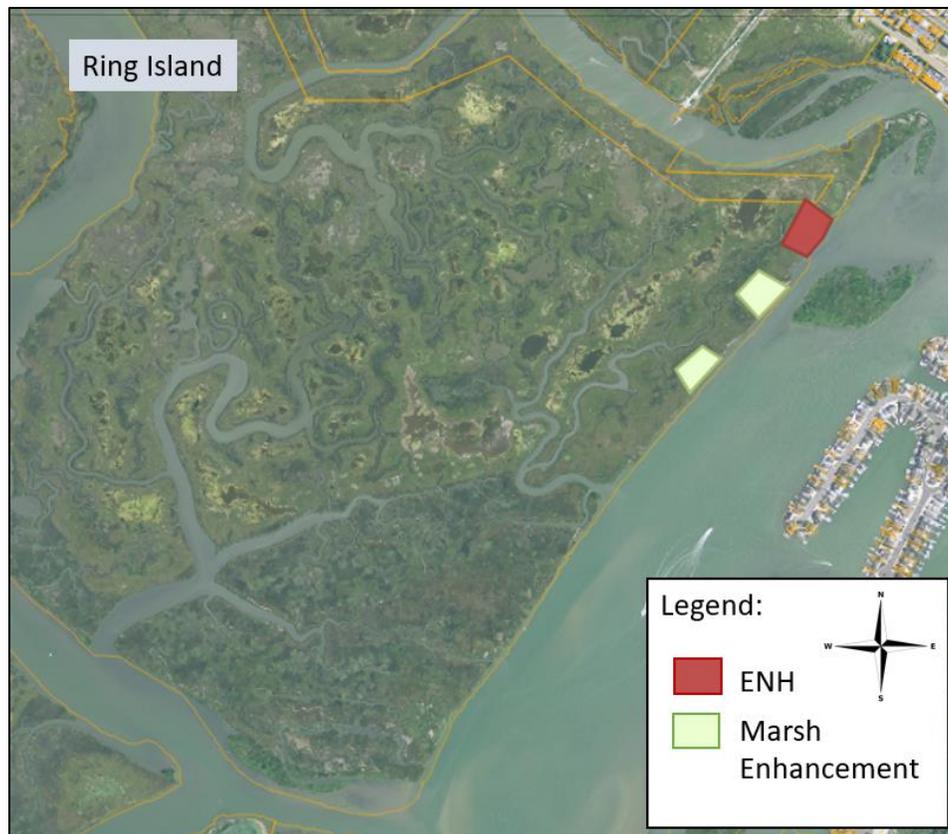
**Figure 12.** This map shows the final placement sites at Ring Island. Elevated Nesting Habitat is marked in red and thin-layer placement areas are in green.

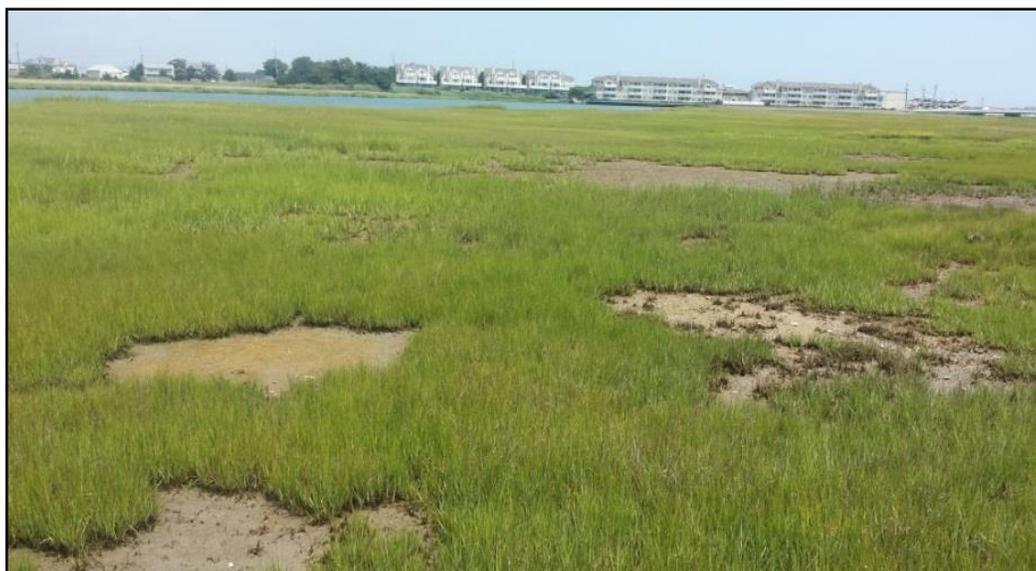
**Figure 13.** Sparse and stunted vegetation was characteristic of the areas of the marsh at Ring Island selected for enhancement via thin-layer placement of dredged material.

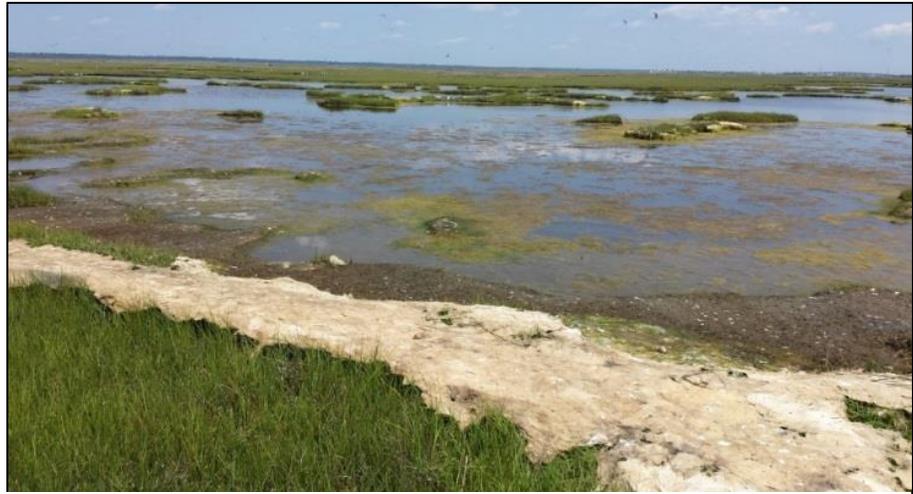
*Figure 14. Expanded and degraded pools were present at the Avalon marsh. The white wrack in the picture is dried algae from the pond.*

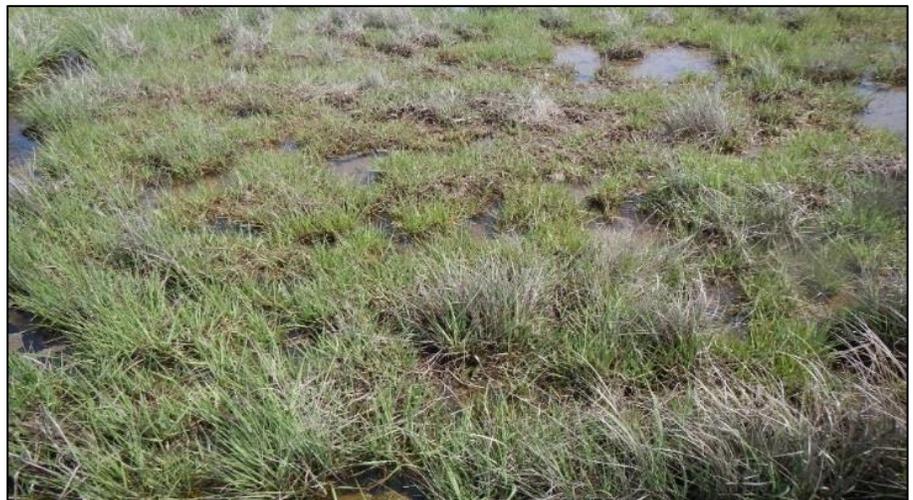
*Figure 15. Vegetation at the Avalon marsh was sparse.*

observations helped the team identify stressed areas of the marsh for enhancement as well as areas of the marsh that were healthy and probably would not benefit from the addition of dredged material. Ultimately, the selected placement areas at Avalon had multiple characteristics typical of stressed marshes, including eroding edges, expanding and degrading pools with undercut banks (Fig. 14), sparse and stunted vegetation (Fig. 15), and minimal faunal usage.

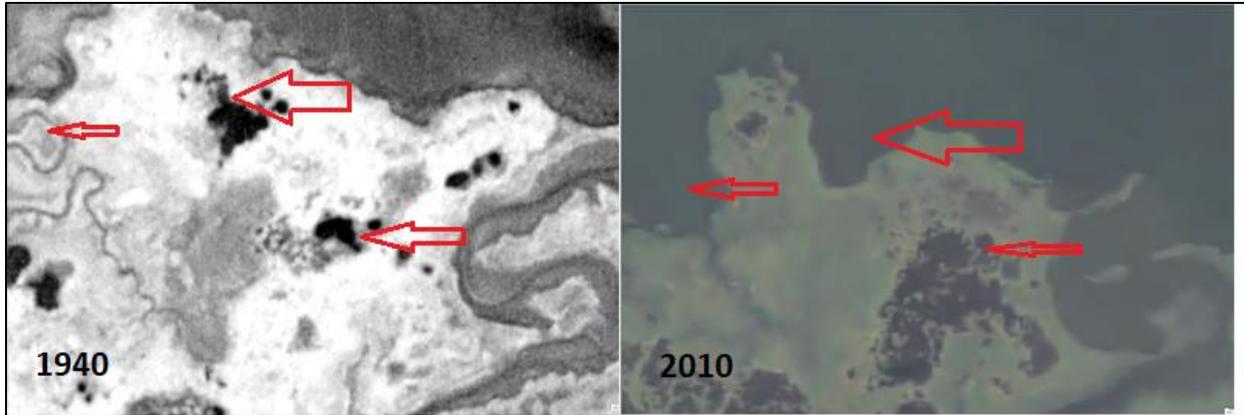
**Figure 16.** These aerial photos of Avalon Area C in 1940 and 2010 reveal conversion of the marsh platform to open water, which was caused by a combination of expanding pools that eroded the marsh edge.

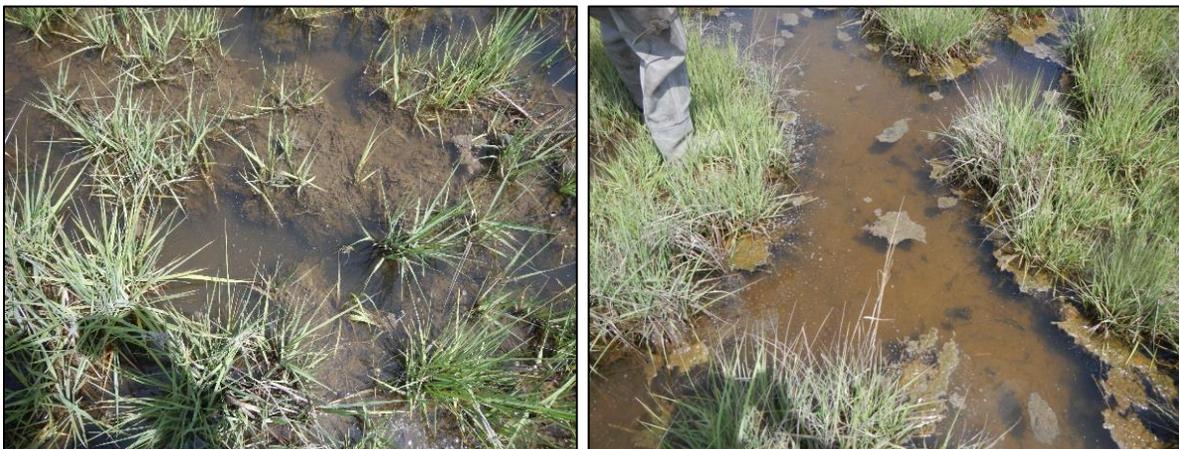
**Figure 17.** At Fortescue, the team noted stunted vegetation on an unstable marsh platform (wobbly hummocks of *Spartina* spp. surrounded by unconsolidated mud).

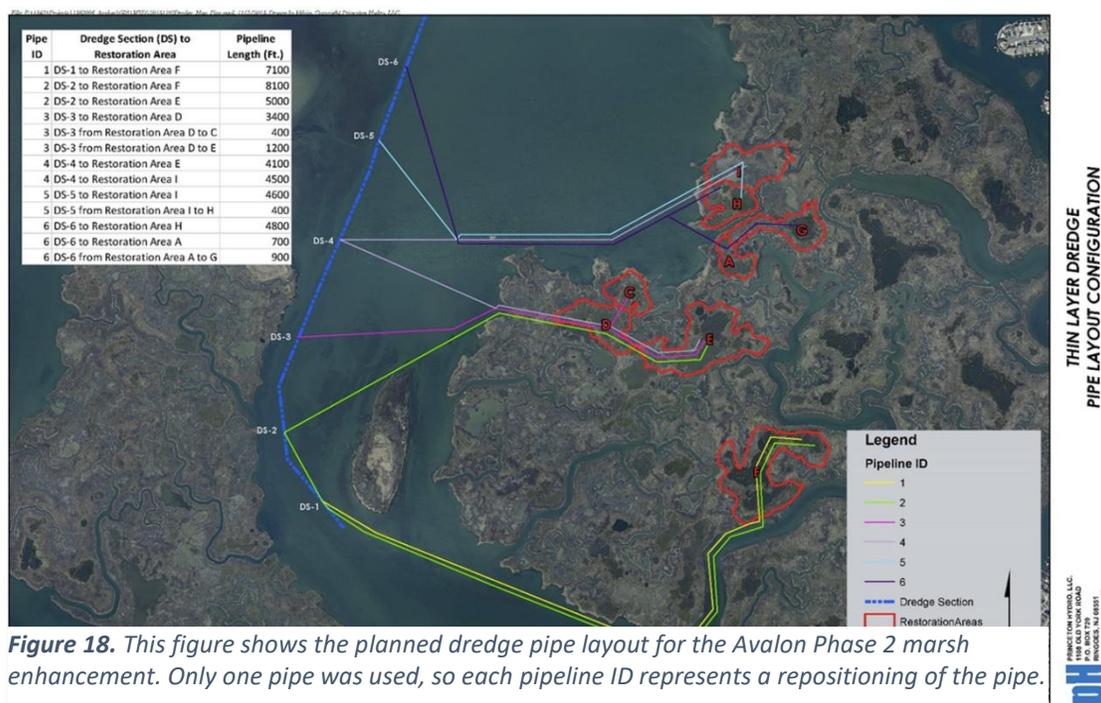
Figure 18. This figure shows the planned dredge pipe layout for the Avalon Phase 2 marsh enhancement. Only one pipe was used, so each pipeline ID represents a repositioning of the pipe.

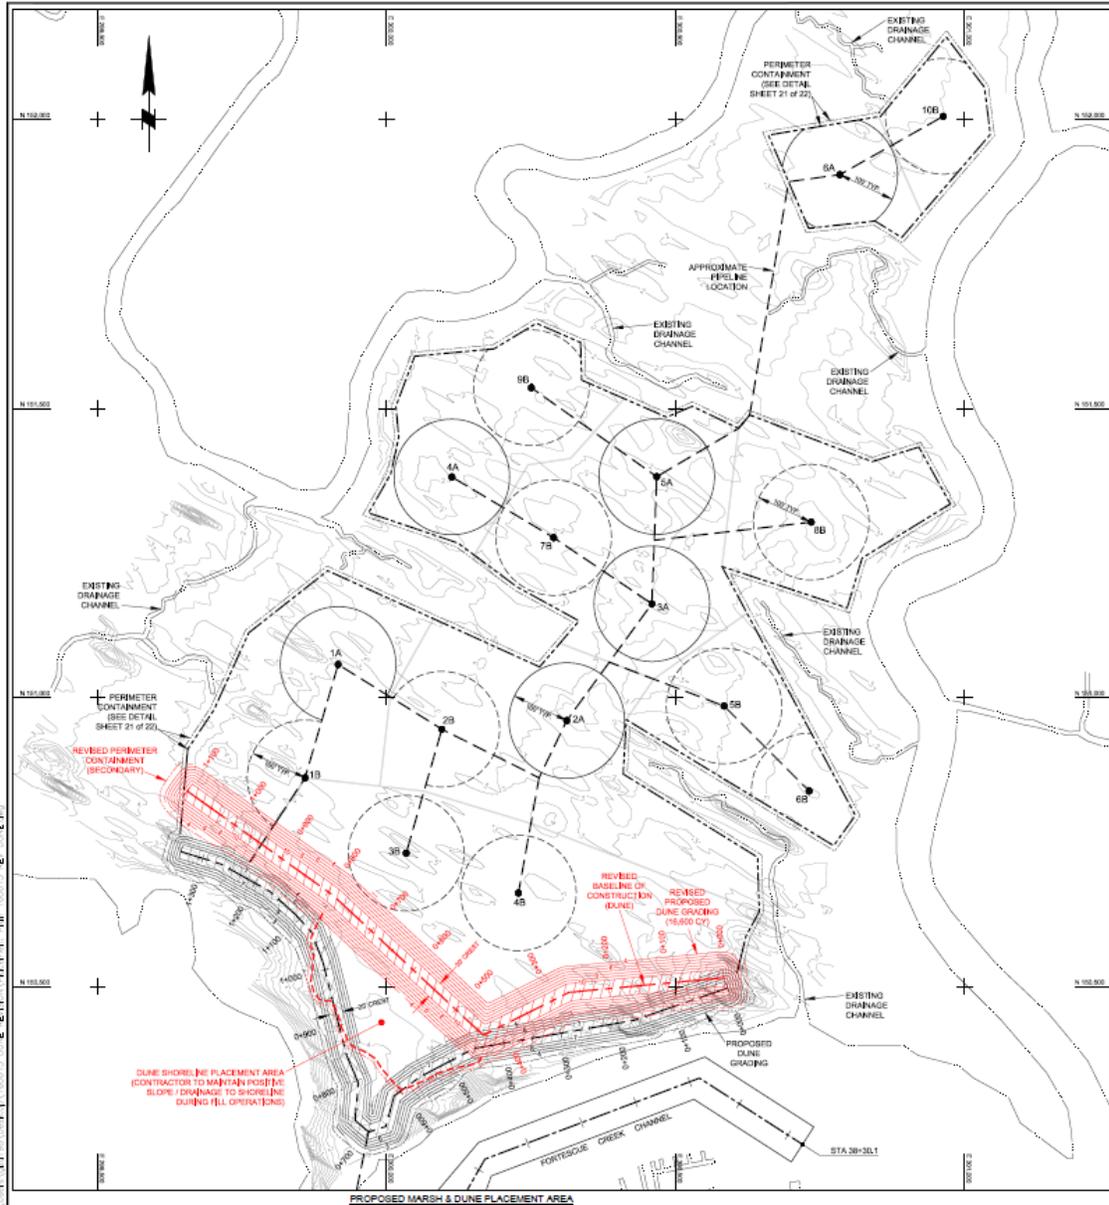
**Figure 19.** This was the original design of the dredge discharge pipe system for the Fortescue marsh enhancement project component. The dune design is in red. The dashed lines represent the pipe layout across the marsh. Circles represent discharge areas where sand was expected to create high marsh. Black dash and dotted lines represent containment around placement areas.

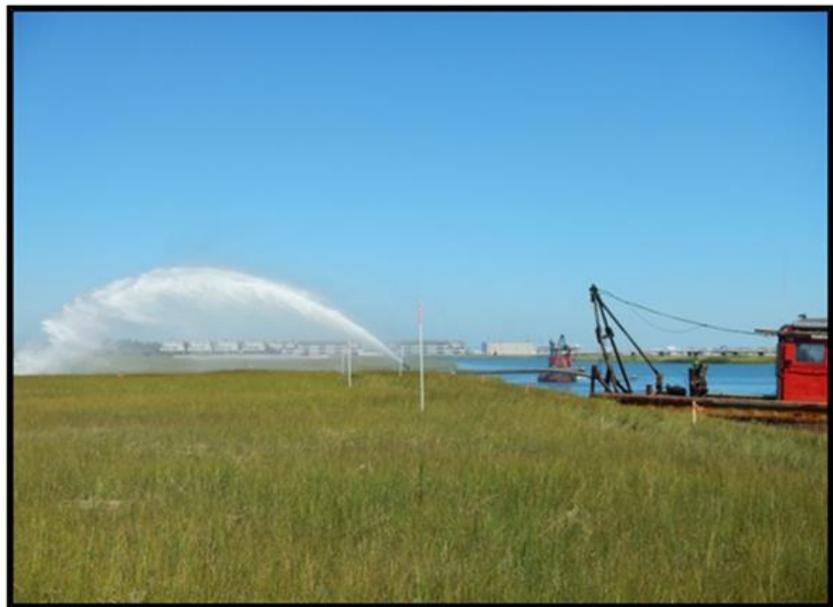
*Figure 19. This photo shows the dredged material spray operation at the Ring Island marsh enhancement project.*

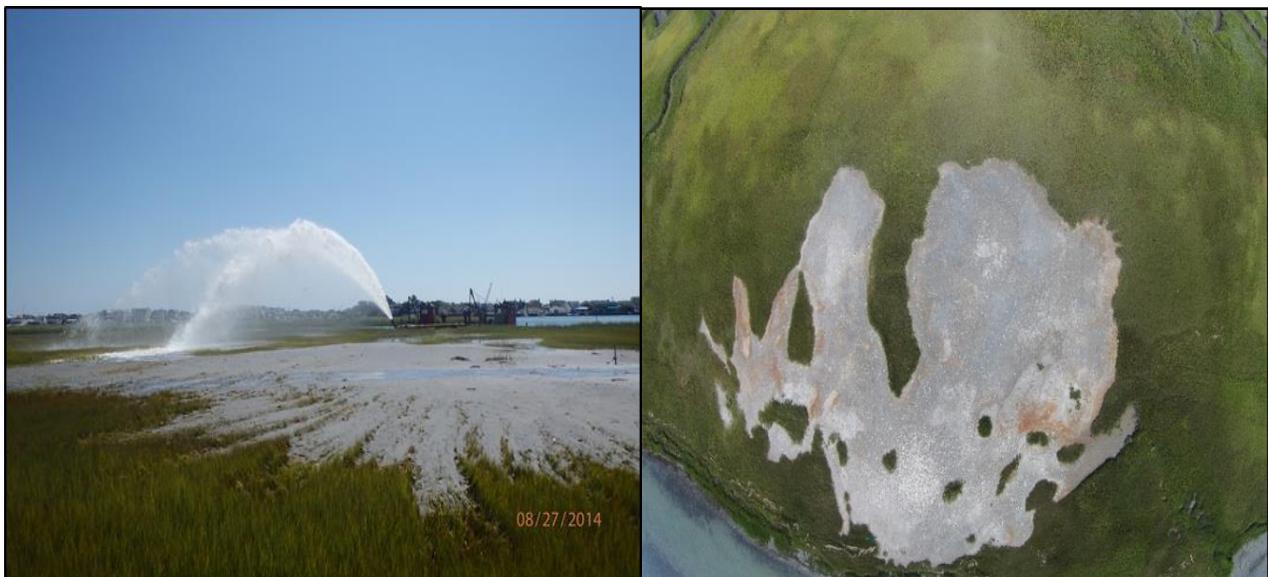
**Figure 21.** Dredged material was placed on the Ring Island Marsh Enhancement site (left). An aerial view shows the placement area TLP-1 after placement (right).

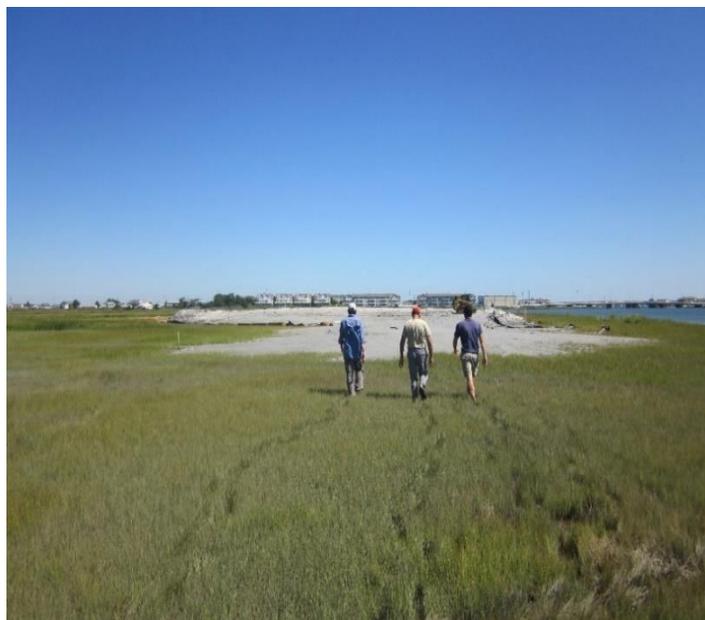
*Figure 22. Dredged material was placed on the Ring Island Enhanced Nesting Habitat site.*

**Dredging and Dredged Material Placement:** Construction of the Ring Island ENH was completed during two weeks in August 2014. This project was built by cribbing the dredge discharge pipe in the approximate center of the site and directly pumping the hydraulically dredged sand onto the site (Fig. 22). As the sand slurry dewatered and accumulated, the cribbing was moved to direct the slurry to different sections of the placement area (Fig. 23). In addition, a baffle plate was attached to the end of the dredge discharge pipe to help spread the sand slurry more evenly. A small-tracked front-end loader moved the sand both during pumping and after dewatering to grade the sand into the final mound with the desired shape, height, and contours (Fig. 24).

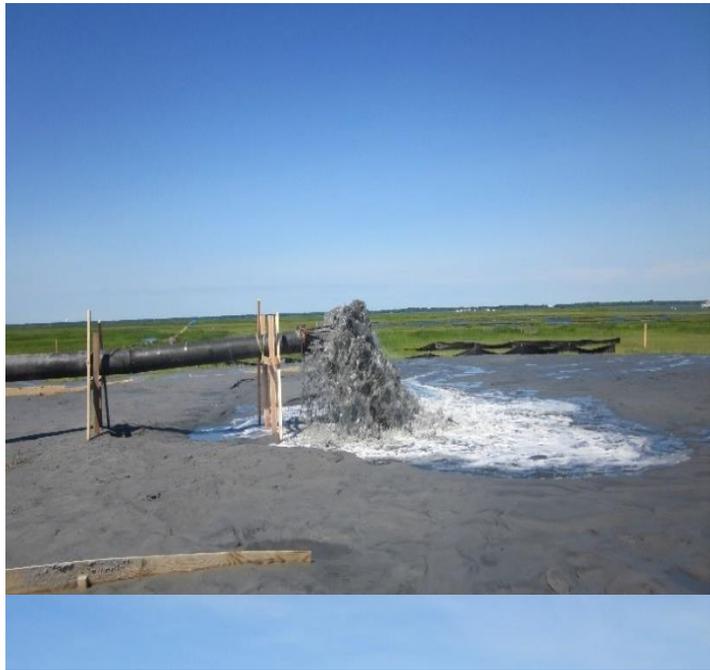
*Figure 23. Containment measures were placed around the Ring Island Enhanced Nesting Habitat site.*

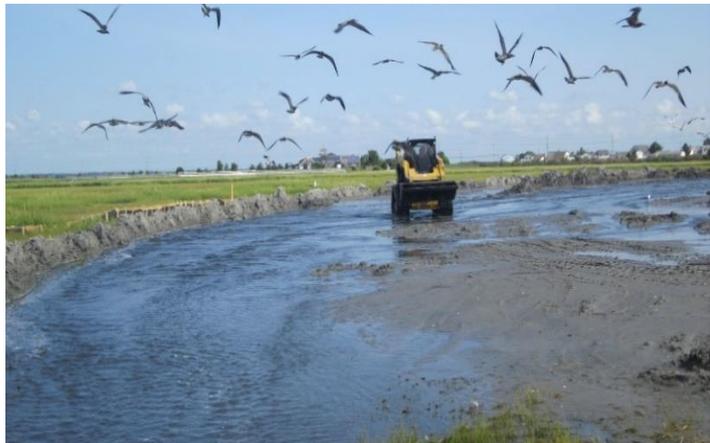
*Figure 24. A front-end loader was used to move the sand during pumping and after dewatering.*

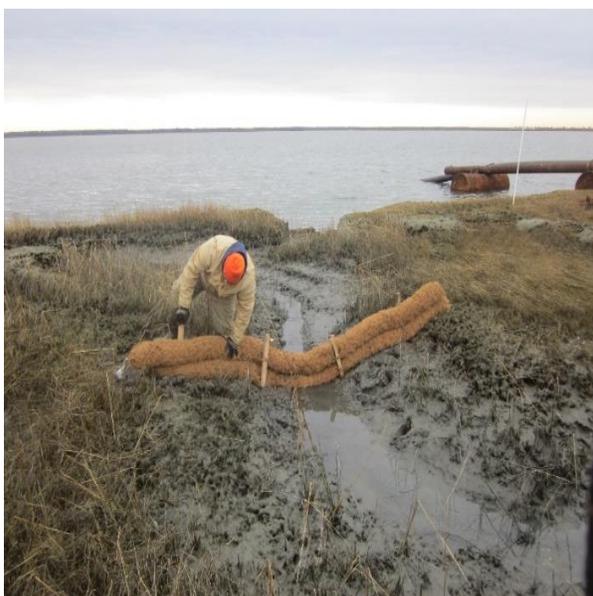
**Figure 25.** At Avalon, a coconut-fiber log containment was installed to minimize the dispersal of the dredged material.

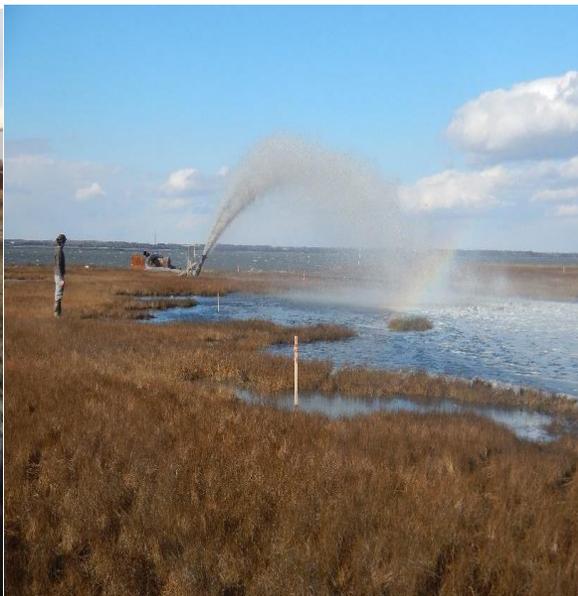
**Figure 26.** At Avalon, grade stakes helped indicate elevations about the marsh surface during dredged material spraying.

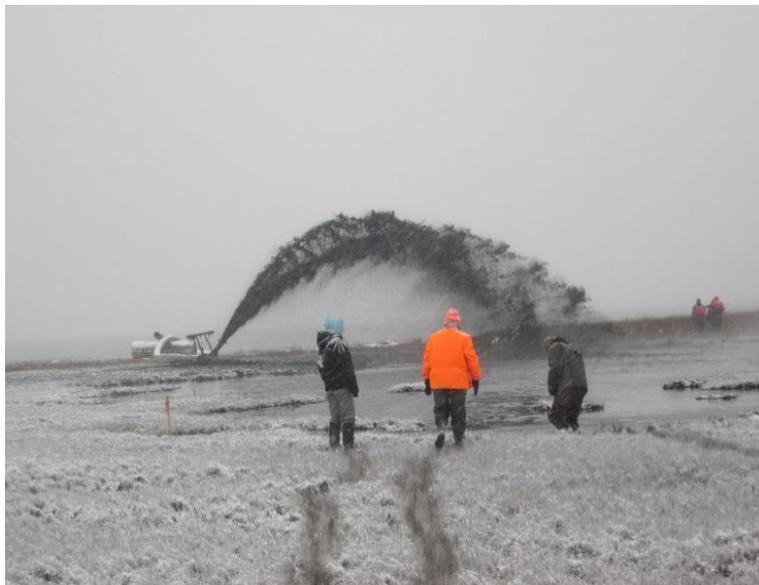
**Figure 27.** At Avalon, dredged material spraying in placement area A used the lessons learned from work at placement area C.

The placement of dredged material in placement area A was implemented using the lessons learned from work at placement area C. Thanks to those lessons, the dredge pipe outlet was cribbed in place farther into the marsh and angled so that the spray landed in the large pool (Fig. 27). To minimize the dispersal of the slurry into nearby creeks, coconut-fiber logs were placed behind the dredge pipe outlet and in low-lying areas. To determine whether the placement in area A was increasing turbidity in the creeks, the team sampled the discharge water around the placement area and in creeks to which it was draining. By the time the discharge water passed through the containment and the narrow strips of tall-form *S. alterniflora* that lined the creek banks (Fig. 28), its turbidity was similar to that of the bay and neighboring creeks. The containment and the creek-bank vegetation, combined, effectively trapped suspended sediment before the discharge water reached the creeks.

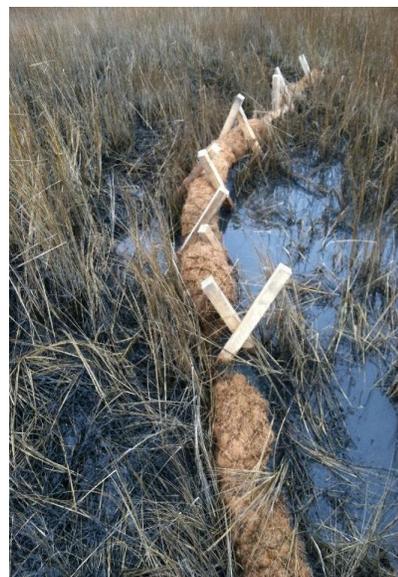
**Figure 28.** At Avalon, coconut-fiber log containment was installed to minimize the dispersal of the dredged material.

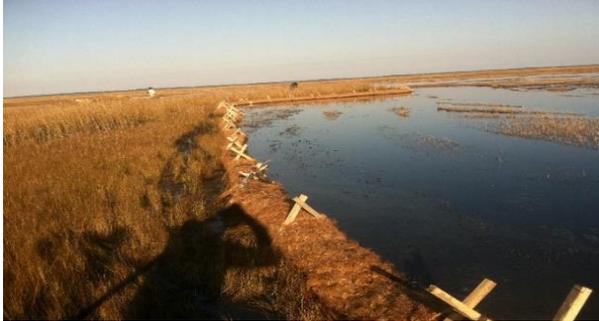
*Figure 29. This photo of Avalon Phase 2 shows the containment area immediately after installation.*

To guide containment installation, a surveyor staked out the perimeter of each area. For containment, the team used coconut-fiber logs ranging from 6 to 20 inches in diameter, depending on the thickness of the planned fill in a given location (the difference between the elevation of the marsh and the target dredged material placement elevation; Fig. 29). For the Avalon Phase 2 project, a crew of 8–10 people spent five weeks installing 15,300 linear feet of containment. The coconut-fiber logs were transported across the marsh and around the staked-out perimeter of each placement area using a low-pressure Marsh Master with a trailer (Fig. 30), the tracks of which inadvertently created unvegetated paths around

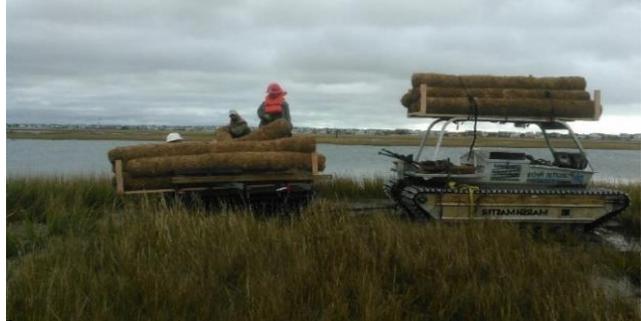
*Figure 30. A Marsh Master and trailer were used to transport the coconut-fiber logs for containment.*

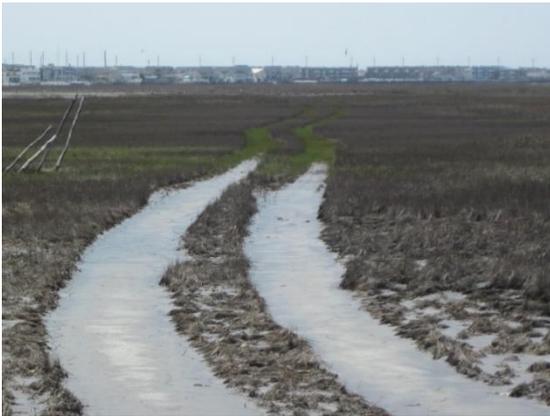
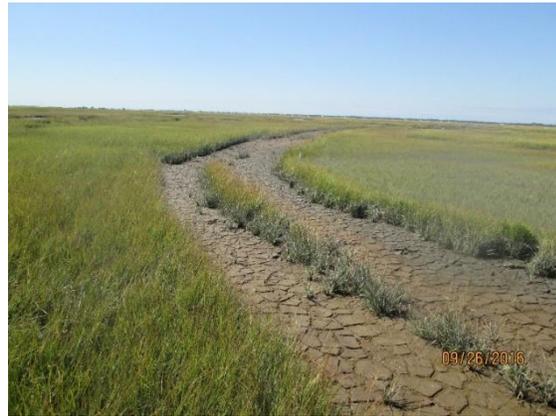
*Figure 31. At Avalon Phase 2, the Marsh Master used to transport the coconut-fiber logs inadvertently created tracks in the marsh.*

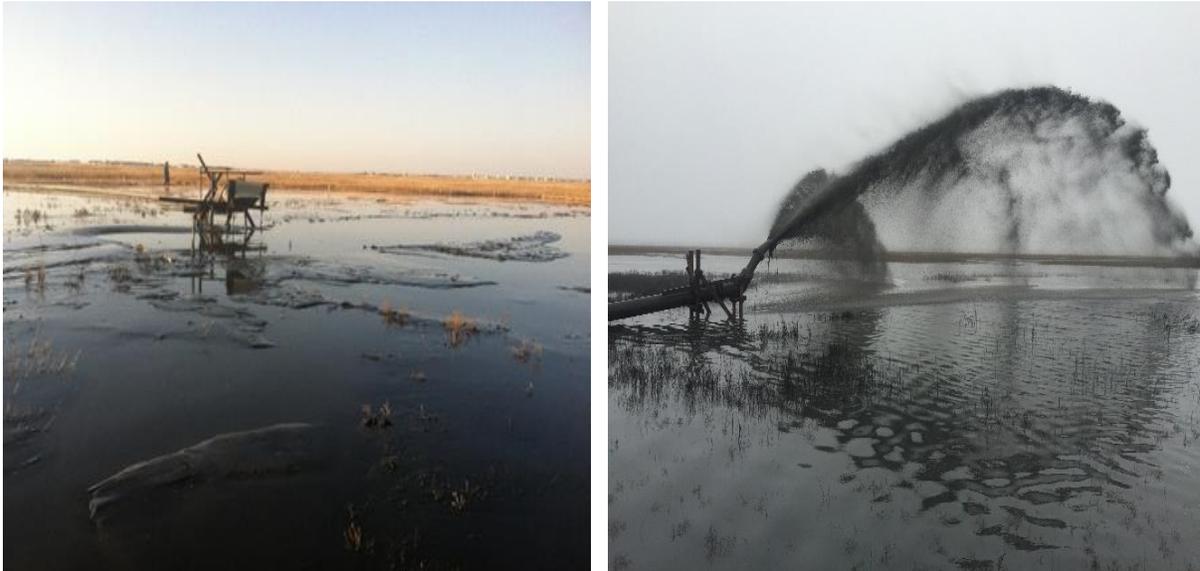
*Figure 32. The dredge pipe outlet at Avalon, Phase 2, was fitted with either a spreader plate (left) or a spray nozzle (right).*

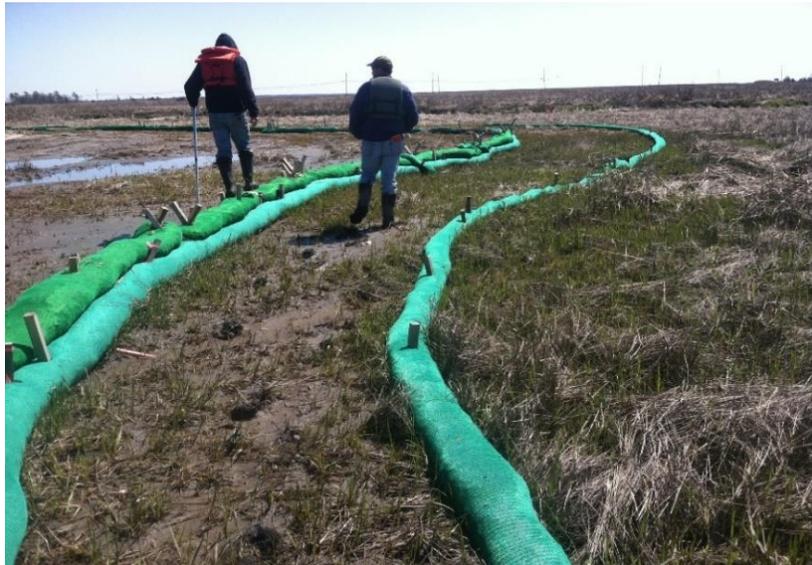
**Figure 34.** At Fortescue, the team installed Filtrexx SiltSoxx™ containment in two concentric rows along the perimeter of the dredged material placement areas.
