# Beneficial Use of Dredged Material to Enhance Salt Marsh Habitat in New Jersey

## Project Summary and Lessons Learned August 2021

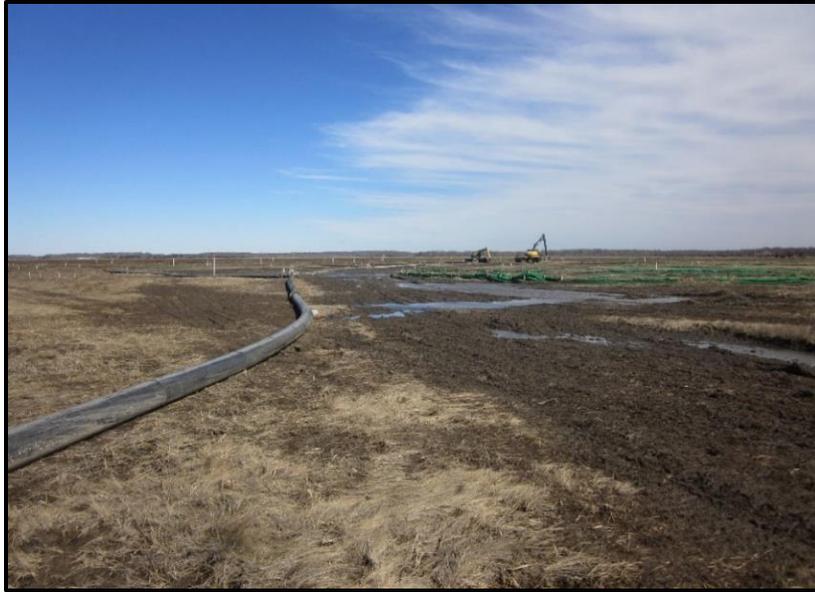
*Figure 35. At Fortescue, damage to the marsh is evident in the right foreground area (darker ground) of this picture. This was caused by repeated travel and other activity over the same area.*

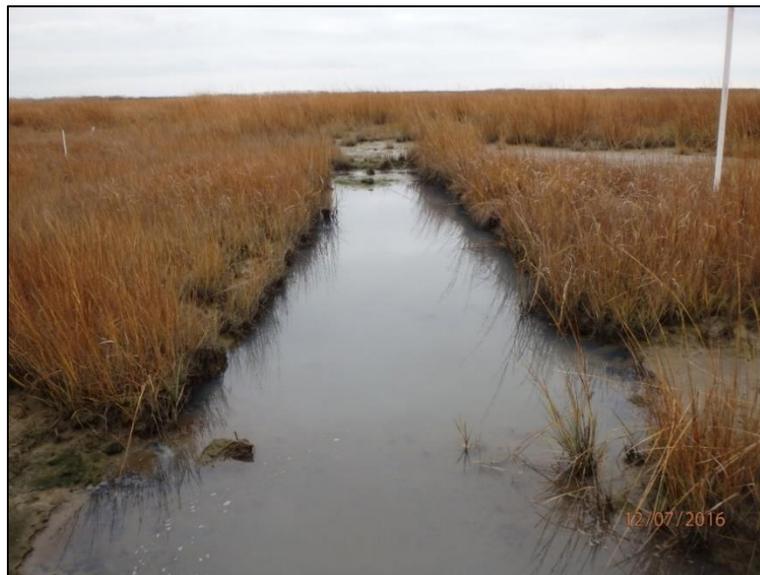
*Figure 36. This long pool was created accidentally by driving an excavator on the marsh at Fortescue.*

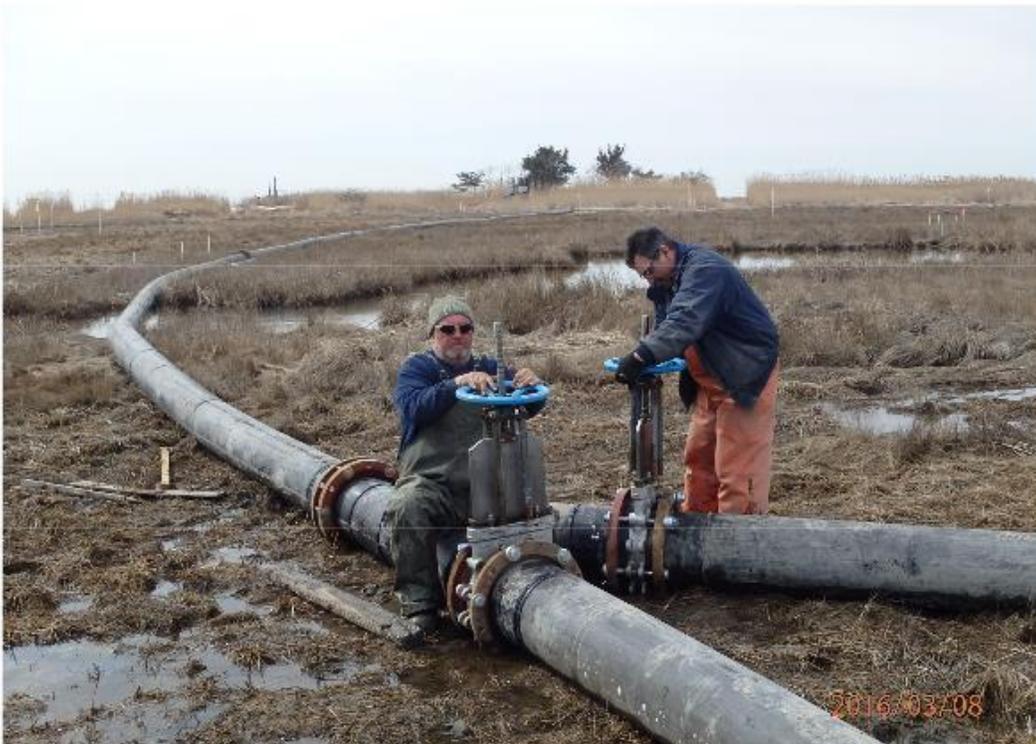
*Figure 37. This y-valve allowed the team to change the location of sediment placement without moving the pipe. Photo from Dewberry Engineers Inc., courtesy of NJDOT.*

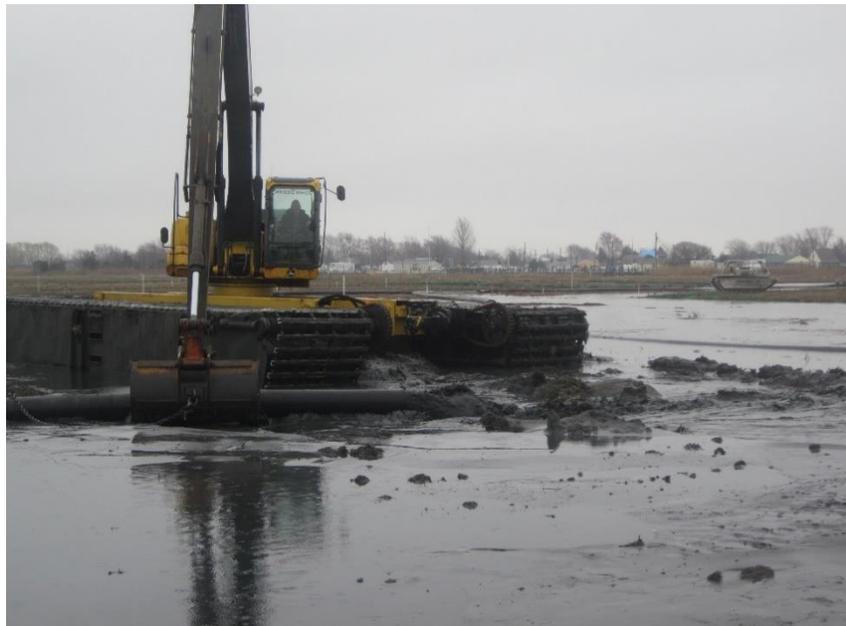
**Figure 39.** At Fortescue, an excavator held and repositioned the dredge discharge pipe outlet.

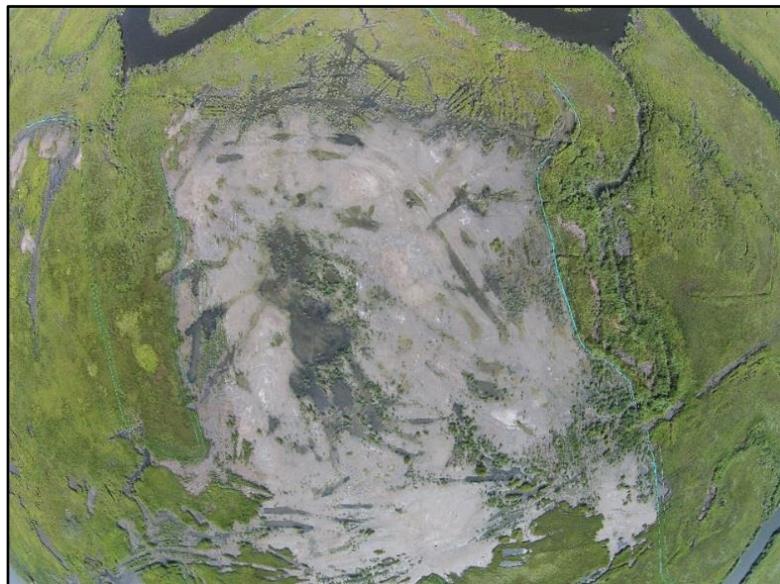
*Figure 40. This aerial view shows Fortescue placement area 1 immediately after placement was completed. Note the Filtrexx Siltsoxx™ containment (bright green lines) near the perimeter.*

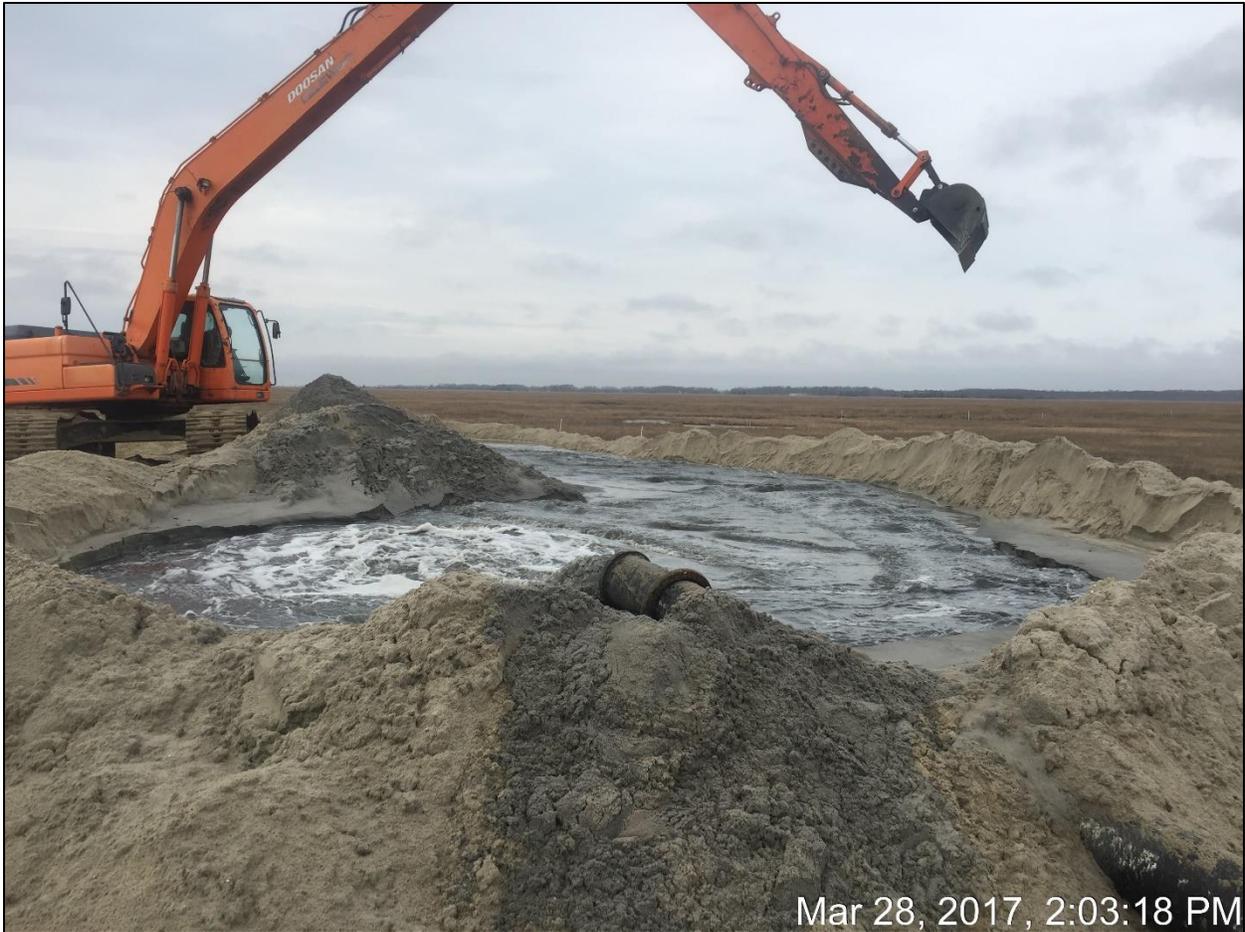
**Figure 41.** At the Fortescue dune restoration, berms were constructed from the first dredged sediment to create dewatering pits to retain the dredged material and to direct the dewatering discharge to the center of the placement area. Photo from NJDOT.

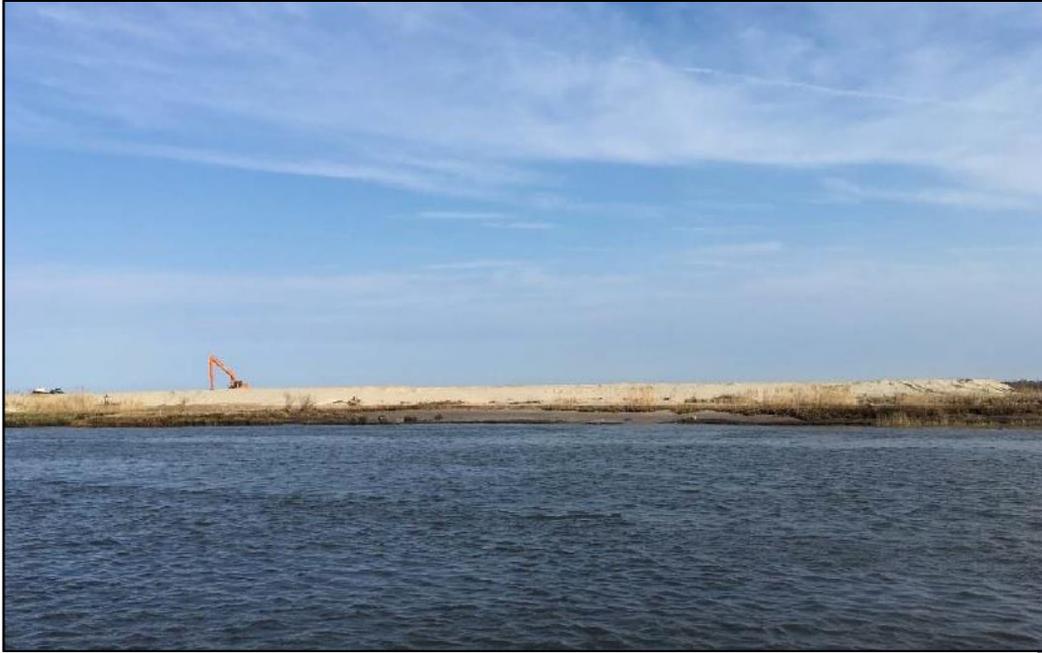
*Figure 41. This photo of the Fortescue dune restoration shows the bay side of the dune immediately after placement.*

**Post-placement:** After placement, NJDOT-OMR performed an as-built survey of the restored dune (Fig. 42). The final dune measured 900 feet long (~200 feet shorter than designed), 40 feet wide at the top and 80 feet wide at the base, with a dune crest elevation of 10 feet NAVD88 (5–6 feet above the marsh surface). The side of the dune graded to a slope of 4:1 (horizontal to vertical). Immediately after placement, the dredge contractor removed the dredge pipe and other construction equipment from the site. The placement area boundary stakes were removed, but the Filtrexx SiltSoxx™ containment was left in place to support the restored dune and minimize erosion into the marsh.

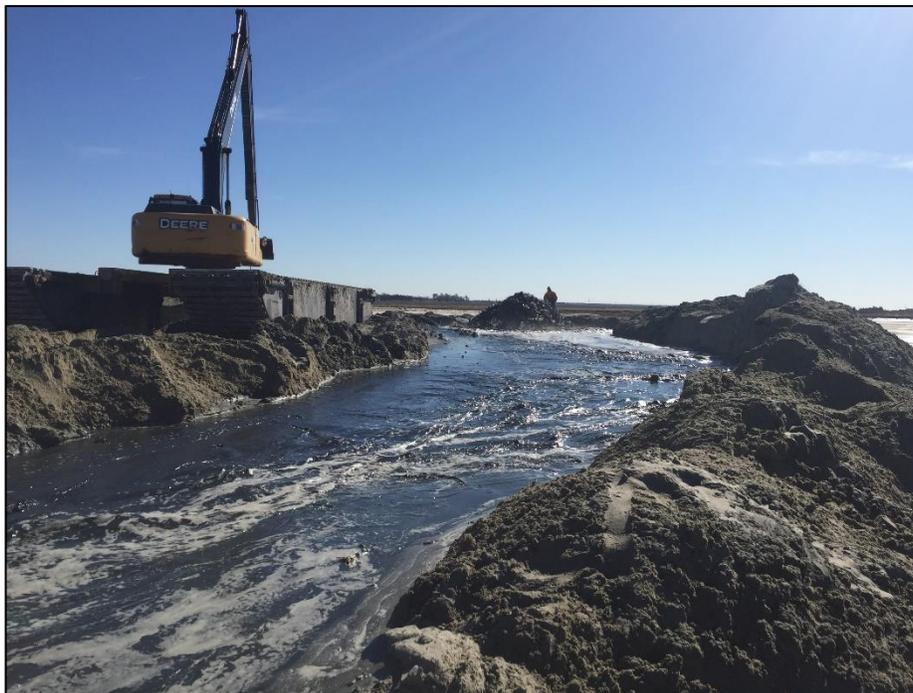
*Figure 43. During the beach restoration component at Fortescue, dredged material flowed in a created trench surrounded by training dikes. Photo from NJ DOT.*

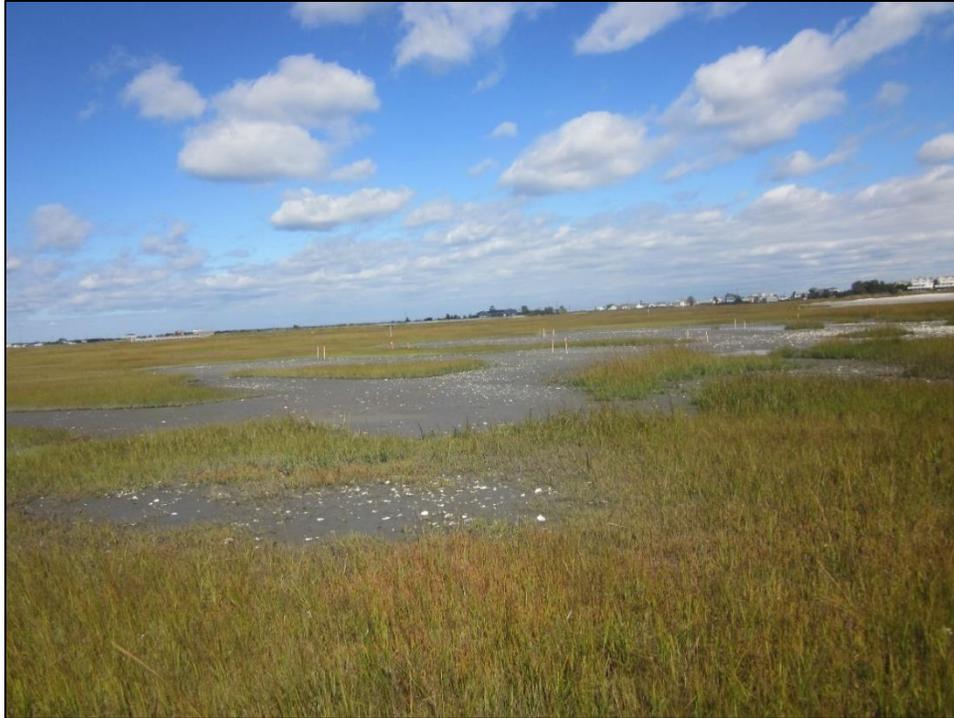
**Figure 44.** At the Ring Island marsh enhancement site in October 2015, there was minimal vegetation recovery and colonization.

- The placed dredged material was heterogenous and its thickness varied across the placement areas.
- Plants that survived the initial placement senesced and died early.
- As birds began to use the placement areas for feeding, shell piles formed.

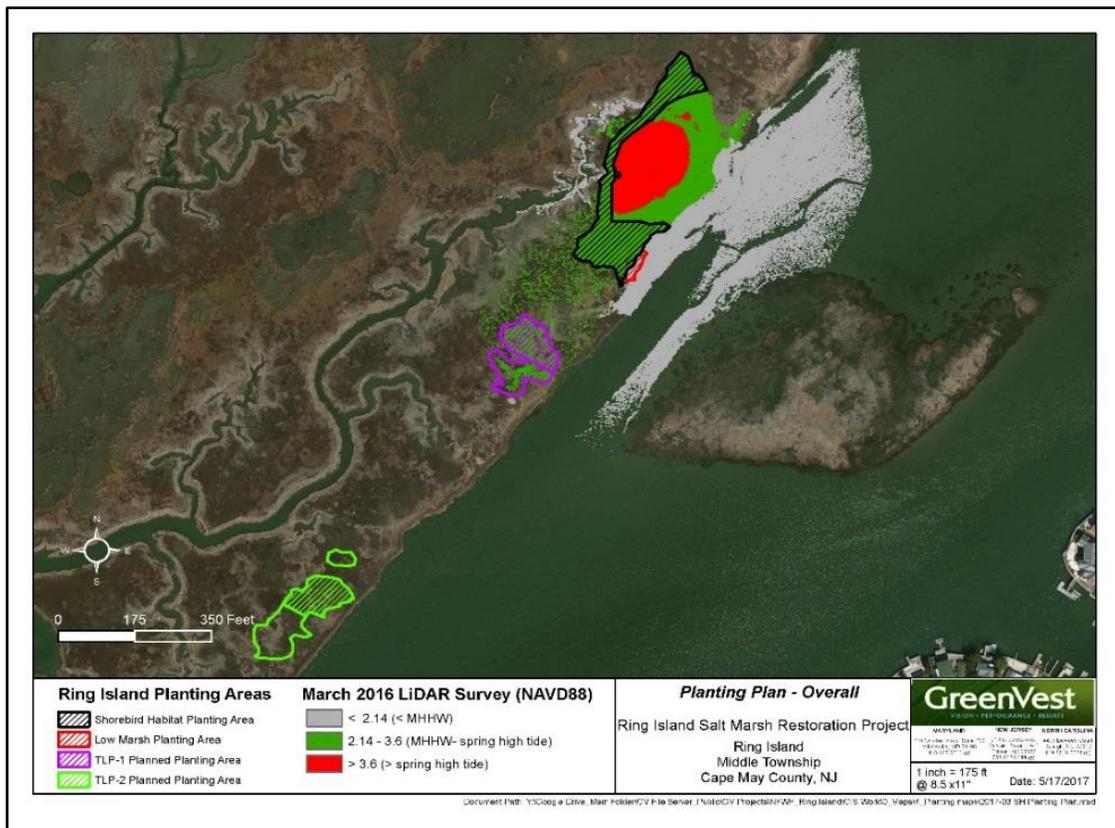
**Figure 45.** This image shows the planting plan for the Ring Island marsh enhancement project.

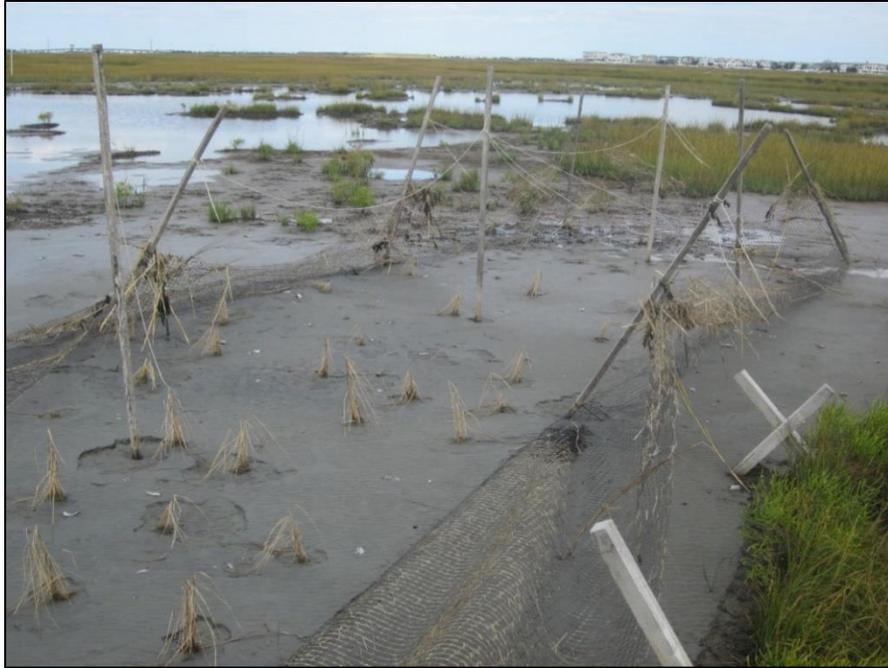
**Figure 46.** By October 2015, few plants survived at Avalon in dredged material placement area A.

According to the as-built survey, the elevation range for placement area A was approximately 2.0 to 2.4 feet NAVD88 and the Avalon biological benchmarks suggested that this was the elevation range of *S. alterniflora* and *D. spicata* (Table 5). However, *D. spicata* was not available from the local nursery at the time of planting, so *S. patens* was used in its place. The planting plan was implemented on July 21, 2015, and consisted of 12 plots with the following treatments: planting vs. no planting (i.e., natural recovery and recolonization), planting at 2-foot centers vs. planting at 3-foot centers, planting *S. alterniflora* vs. *S. patens*, and planting with goose netting versus no netting. By September 2015, only a few *S. alterniflora* plants survived (Fig. 46).

The marsh team presumed that plant survival was poor because conditions in the middle of the growing season (late July) are not conducive to plant establishment. Other possible contributing factors include the chemical composition of the dredged material and lack of adequate pore space in the tightly consolidated fine-grained sediment.

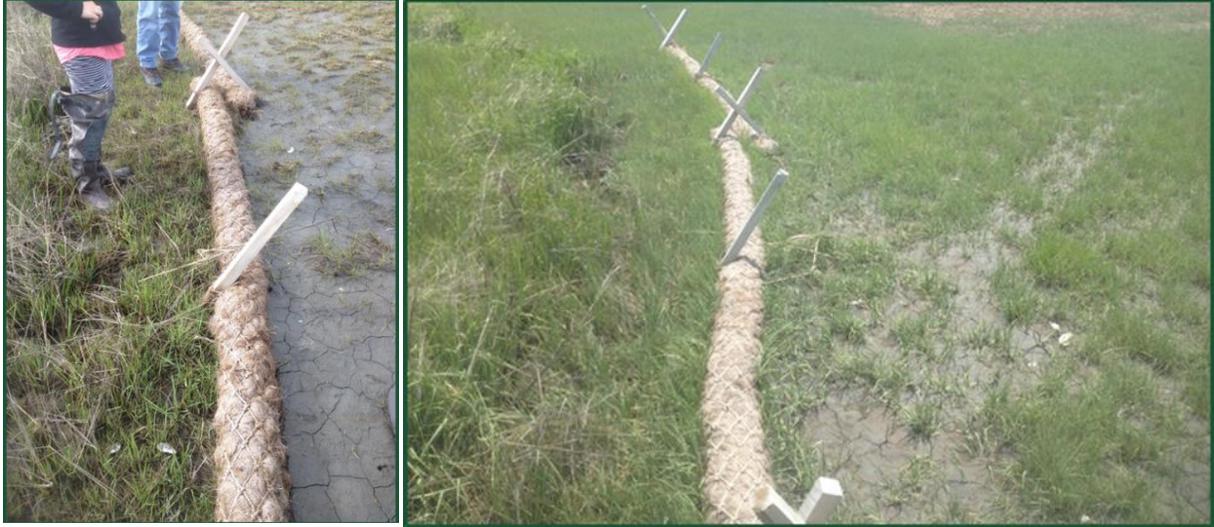
**Figure 47.** At Avalon, existing marsh plants grew through placed dredged material in April (left) and June 2015 (right).

Despite the failure of the experimental planting, by September 2015, *S. alterniflora* grew vigorously through the placed dredged material at some locations in placement area A (Fig. 47). However, recovery was patchy, and in some areas, vegetation died. Overall, vegetation recovery during the 2015 growing season was too variable to draw any firm conclusions about the marsh response.

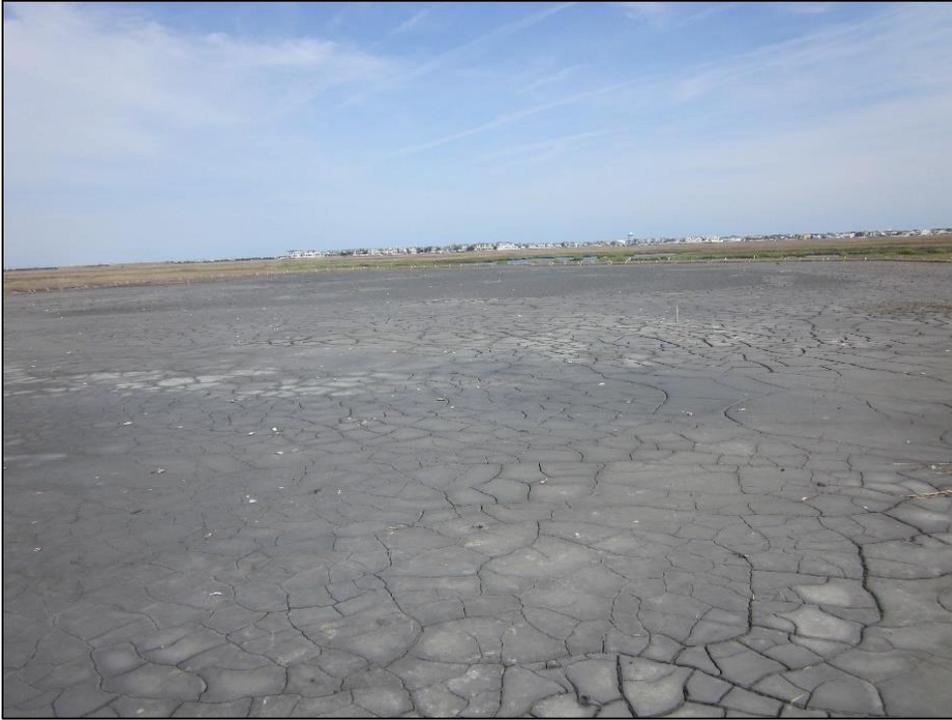
**Figure 48.** At Avalon, Phase 2, thick plates of drying and cracking dredged material were present in April 2016 (two months after construction was completed).

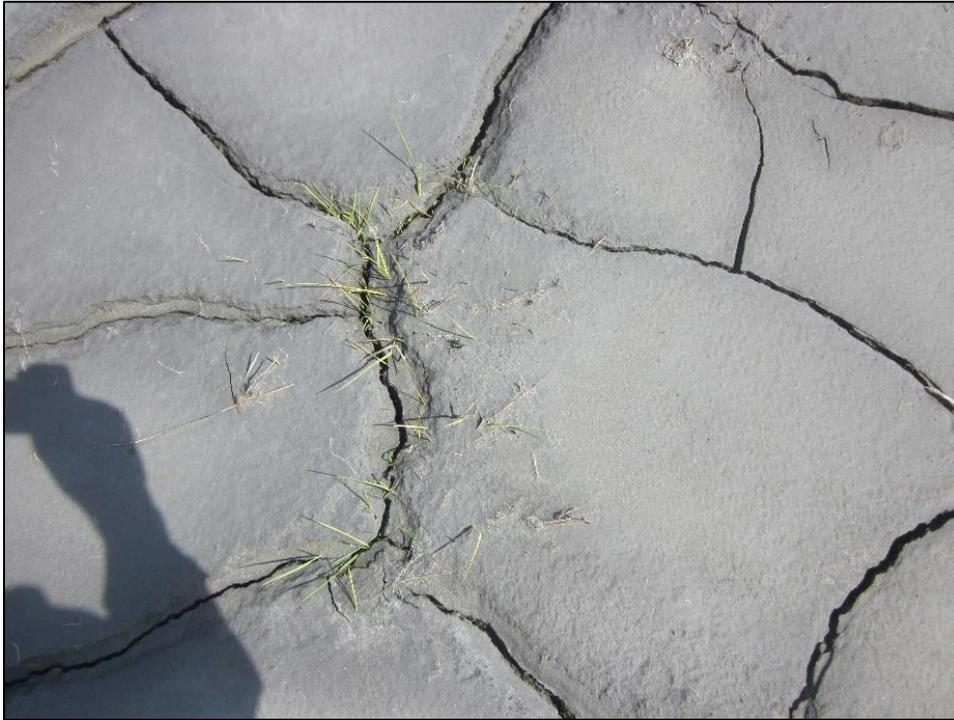
**Figure 49.** At Avalon, Phase 2, *S. alterniflora* grew through some of the cracks in the dredged material.

- During the two months since construction had been completed, the extent of consolidation for the dredged material was highly variable.
- Due to dewatering and drying, the dredged material had formed thick plates in a number of areas (Fig. 48).
- At some locations, *S. alterniflora* was growing through the cracks in the dredged material (Fig. 49).
- Vegetation did not recover in the tracks left by the Marsh Master (Fig. 31).
- Water created drainage paths through some of the placement areas.
- It was difficult or impossible to walk across both former pools and sediment dominated by fine-grained material.

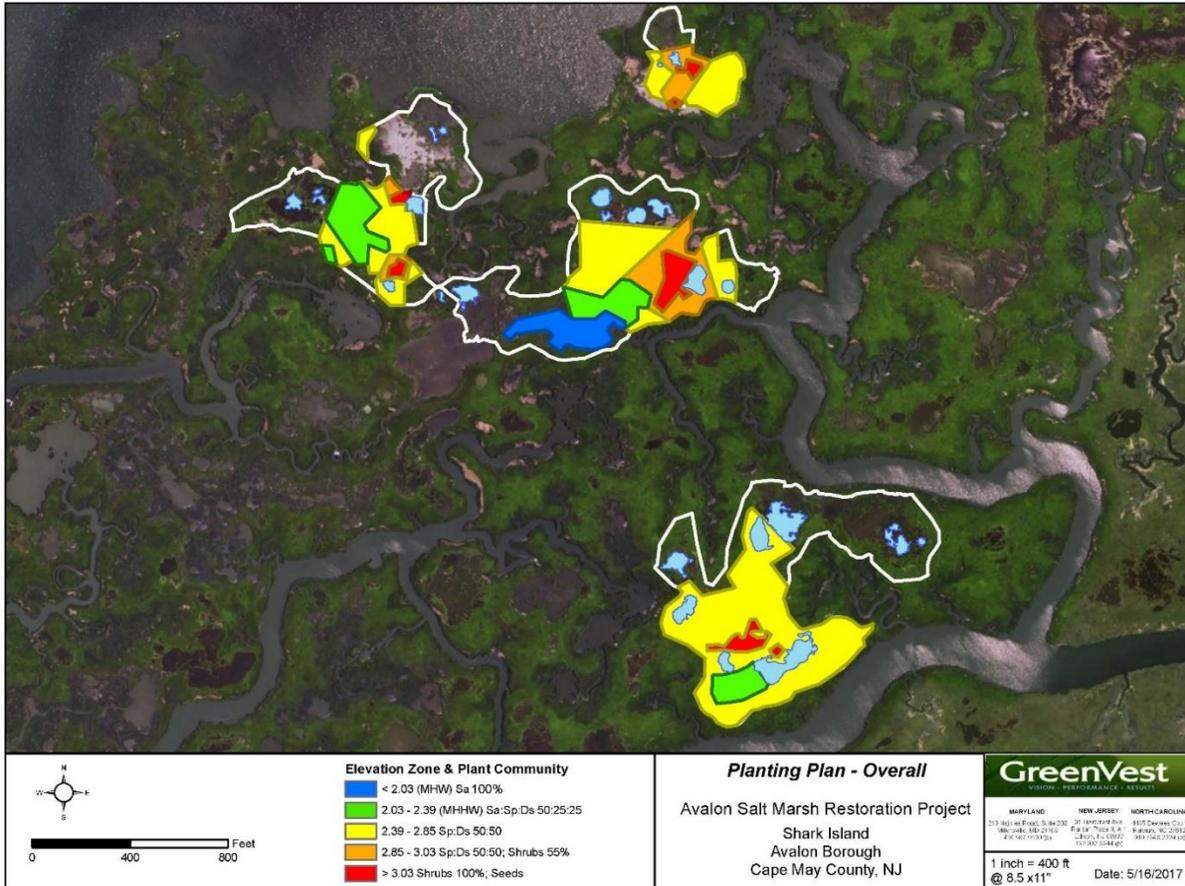
**Figure 50.** Species selected in the Avalon Phase 2 planting plan were *Spartina alterniflora* (*Sa*), *S. patens* (*Sp*), *Distichlis spicata* (*Ds*), *Iva frutescens* (*If*), and *Baccharis halimifolia* (*Bh*).

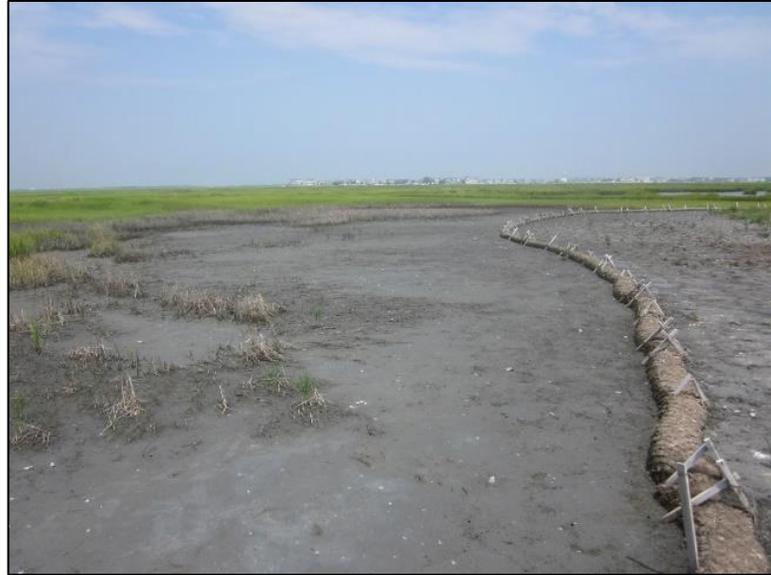
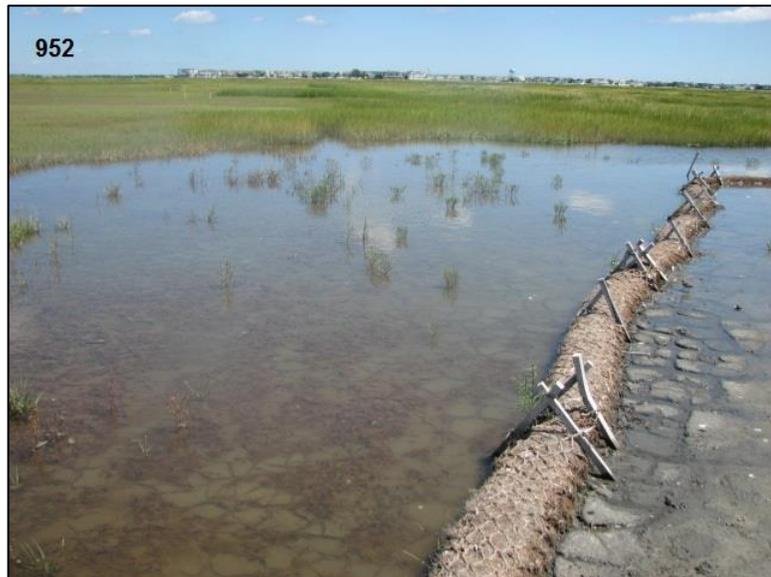
*Figure 51. At Avalon Phase 2, vegetation die-off (brown areas outside containment) occurred (top). The containment restricted tidal flow, keeping water higher outside the placement area than inside it. Photos from NJDEP.*

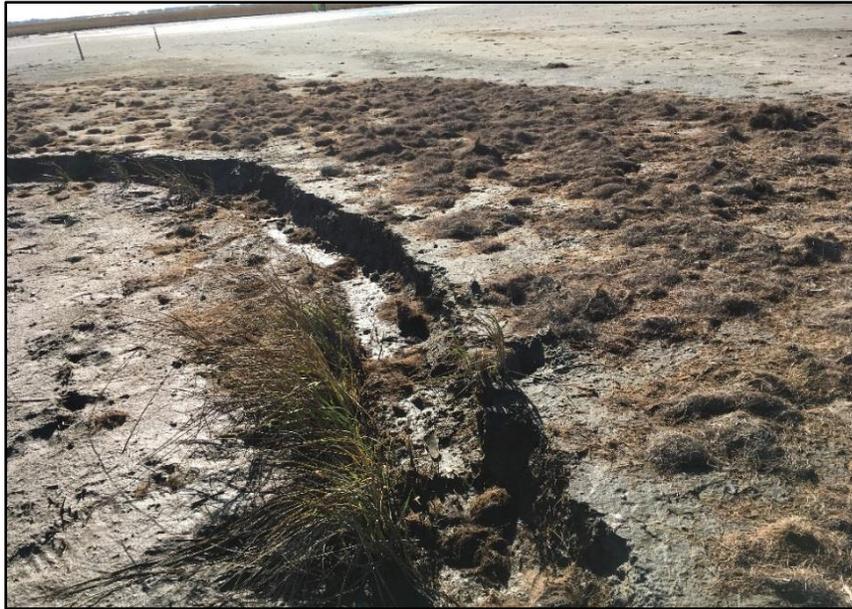
*Figure 52. Avalon Phase 2: Containment was removed from this section (dark line curving from bottom center to upper left) and the biodegradable coconut fibers (right of line) from the containment were spread over the marsh. The elevated placement area is to the right.*

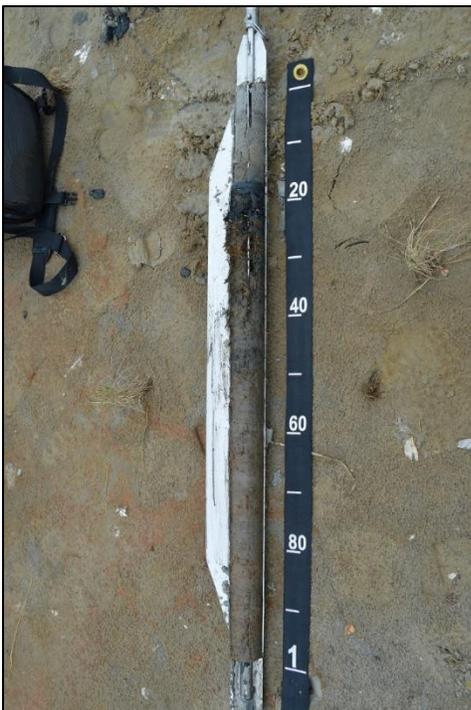
*Figure 53. Acid sulfate soils with a pH below 3.8 appeared reddish and were found in the higher, drier, and sandier portions of the Avalon placement area. Photo from NRCS.*

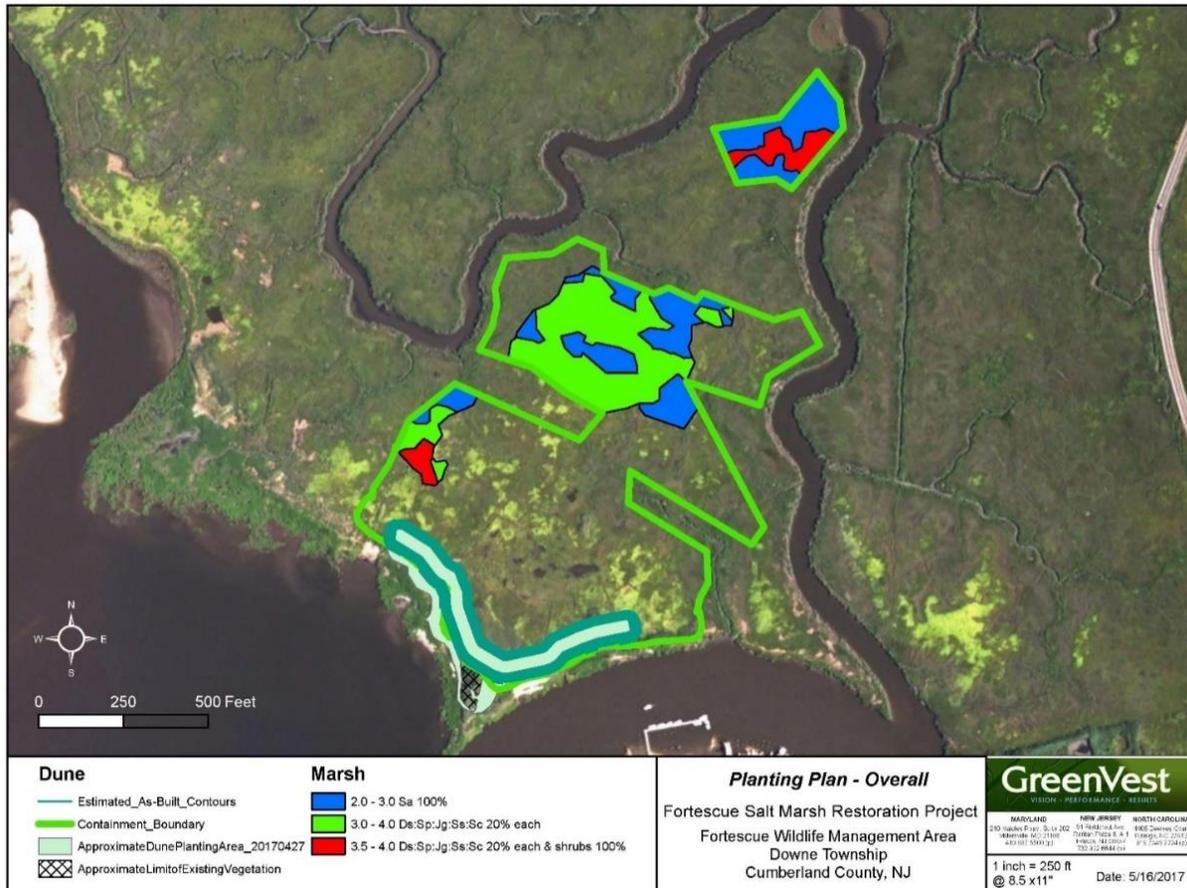
**Figure 54.** Species selected for the Fortescue marsh enhancement component were *Spartina alterniflora* (Sa), *S. patens* (Sp), *Distichlis spicata* (Ds), *Juncus gerardii* (Jg), *S. cynosuroides* (Sc), *Solidago sempervirens* (Ss), *Iva frutescens* (If), and *Baccharis halimifolia* (Bh).
